HURRICANE CHARLEY

**Post-storm Beach Conditions and Coastal Impact Report
with
Recommendations for Recovery and Modifications of Beach
Management Strategies**

**Florida Department of Environmental Protection
Division of Water Resource Management
Bureau of Beaches and Coastal Systems
August 2004**

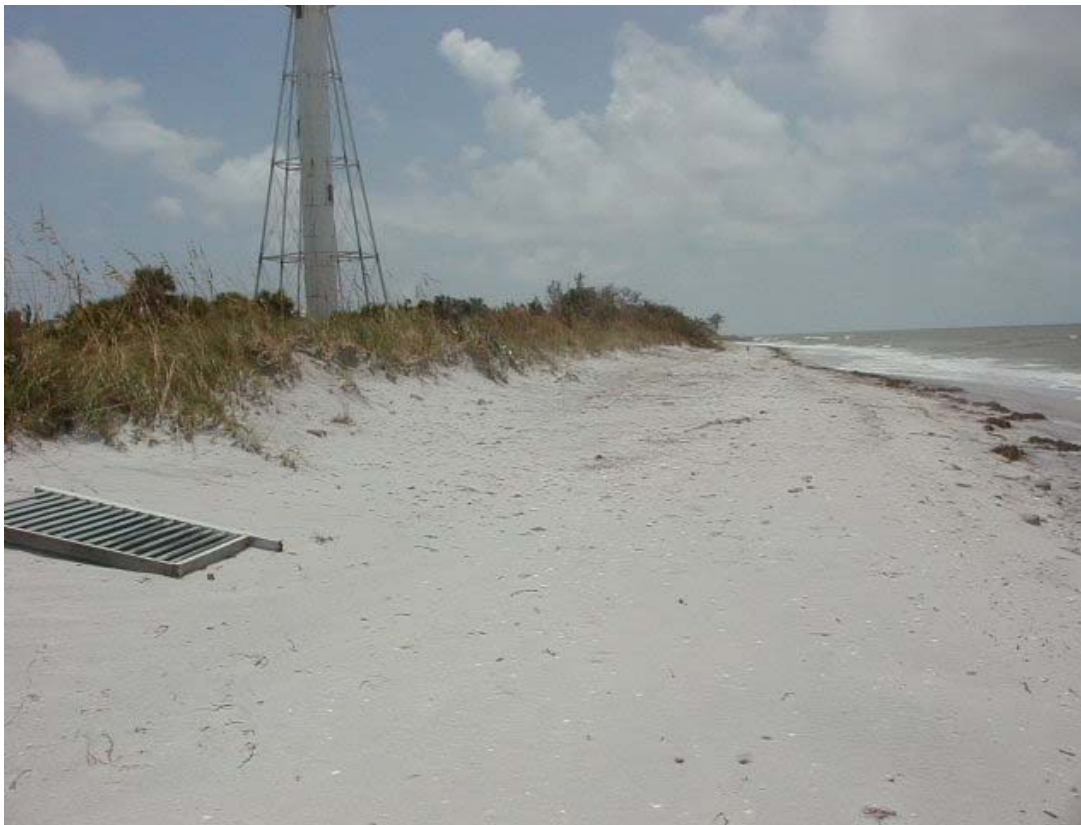
Throughout the length of Gasparilla Island only minor beach erosion (Condition I) prevailed (Photo 1). Gasparilla Island was on the lee side of Charley's eye and a storm surge was estimated to be between +4 and +5 feet in this area. The southern 4.1 miles of Gasparilla Island between Lee County DEP Reference Monuments R7 and R26 is designated as critically eroded. Much of the area is armored with seawalls and revetments. No significant damage was observed to these coastal protection structures; however, some scouring of the beach and nearshore was observed.

Photo 1. Minor beach erosion at Gasparilla State Park
(Lee County DEP Reference Monument R17)

- Implementation of the existing beach management strategy that includes beach restoration is recommended.

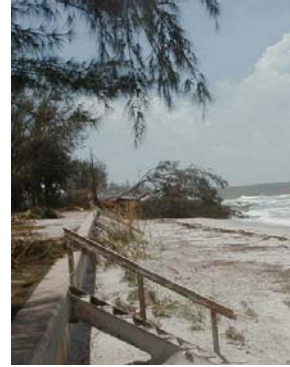
The island's leeward position to the hurricane's eye is evident in the southward fallen trees (Photo 2). A duplex at R25 was highly exposed to the north wind and its roof blew off to the south (Photo 3).

Photo 2. Downed tree.

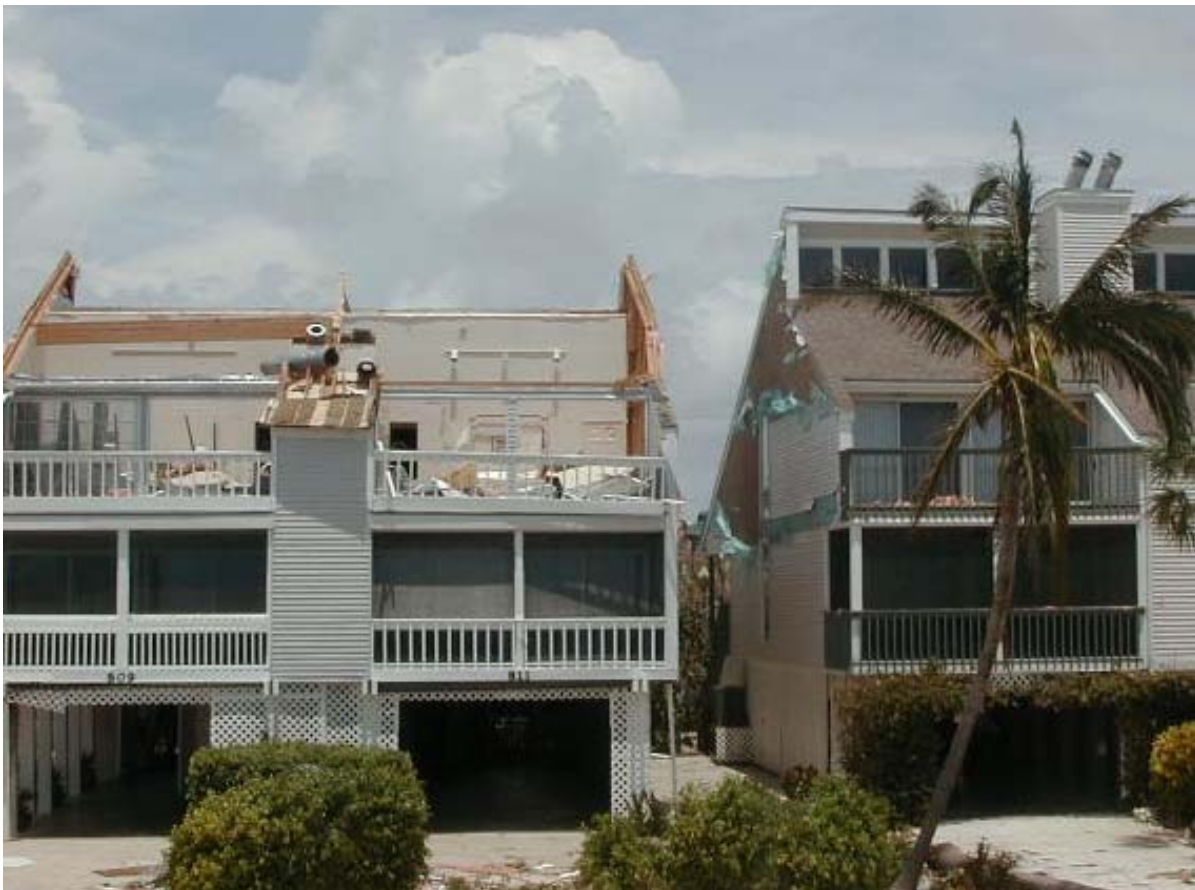
Photo 3. Belcher Road dwelling with roof damage (R25)

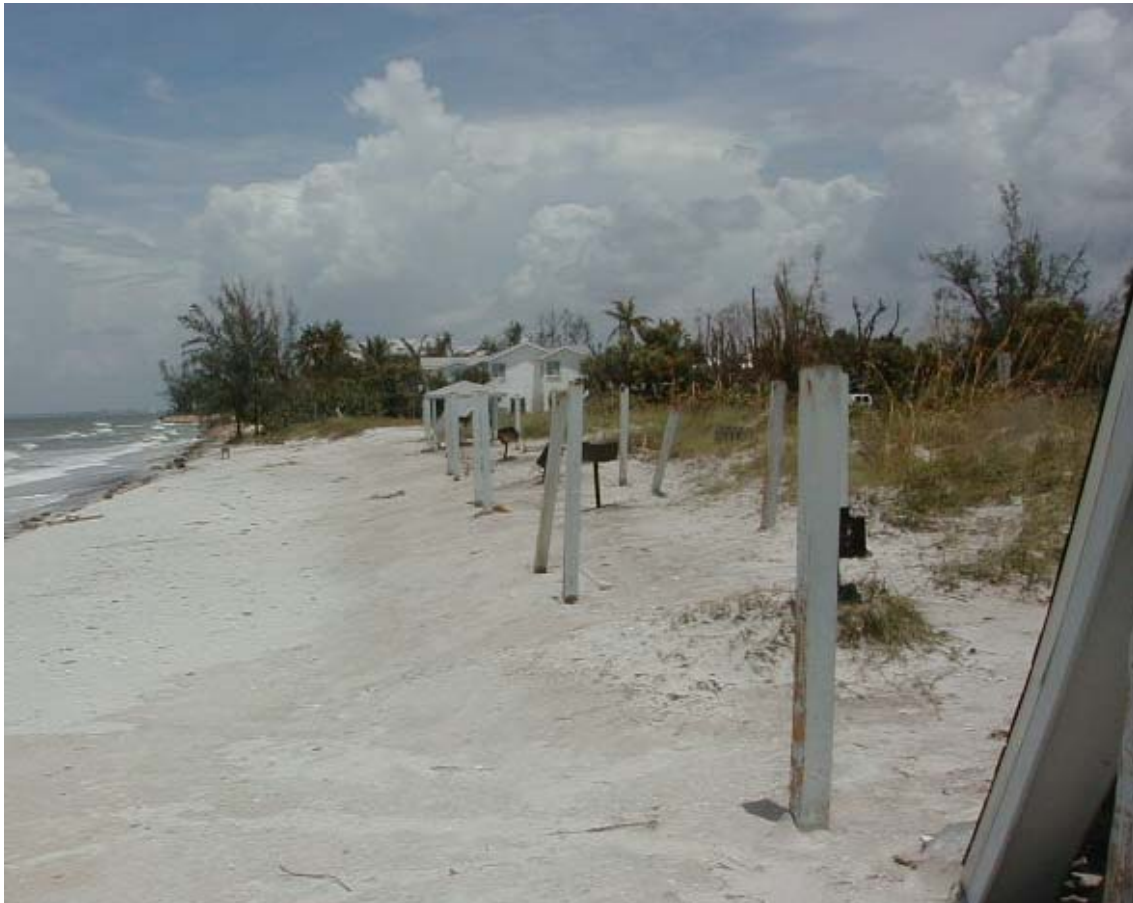
At the Gasparilla Island State Park between R16 and R17, the roofs of seven out of eight gazebos blew off (Photo 4).

Photo 4. Gasparilla State Park shelters had roofs blown off.

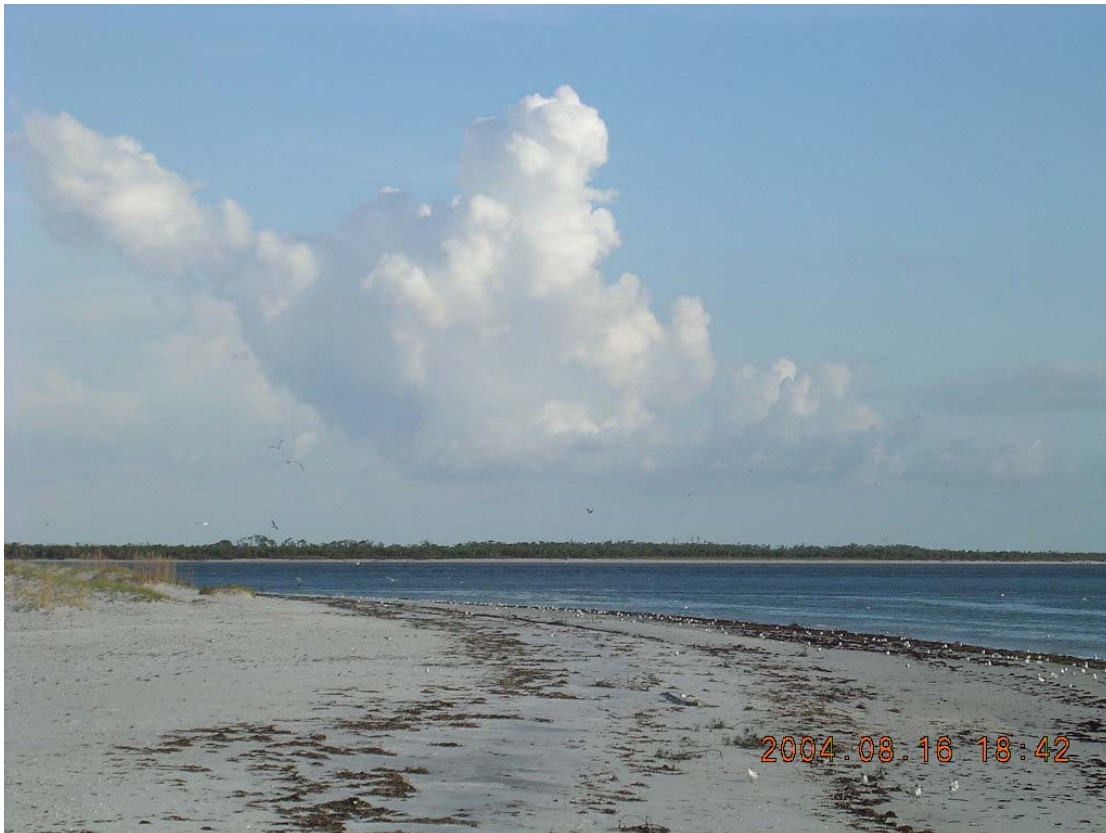
To the south of Boca Grande Pass and extending for 7.1 miles to Captiva Pass is the generally undeveloped barrier island of Cayo Costa (Photo 5). Three areas on Cayo Costa have been designated as noncritically eroded. The northern segment (R27-R33) extends for 1.1 miles, the central segment (R46-R52) extends for 1.2 miles, and the southern segment (R60-R65) extends for 1.0 mile.

Photo 5. View of Cayo Costa looking across Boca Grande Pass

- Additional shoreline assessment should be conducted when aerial videography is available.
- Natural recovery is recommended.

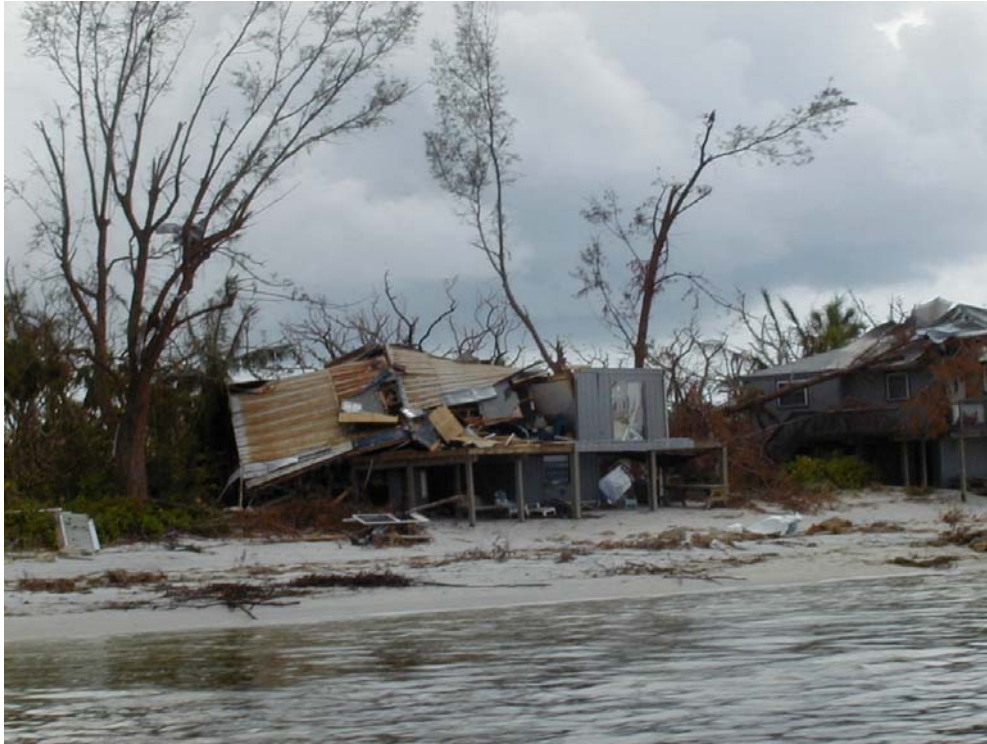
Photo 6. North Captiva Island dwelling destroyed.

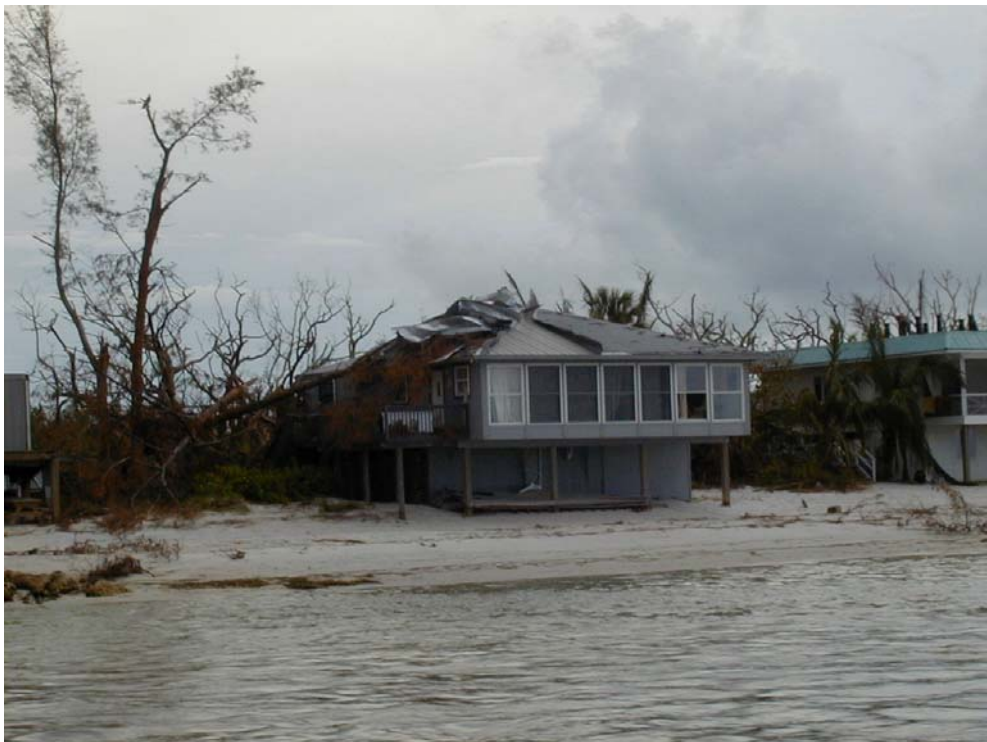
Photo 7. Typical structure damage to dwellings on North Captiva Island.

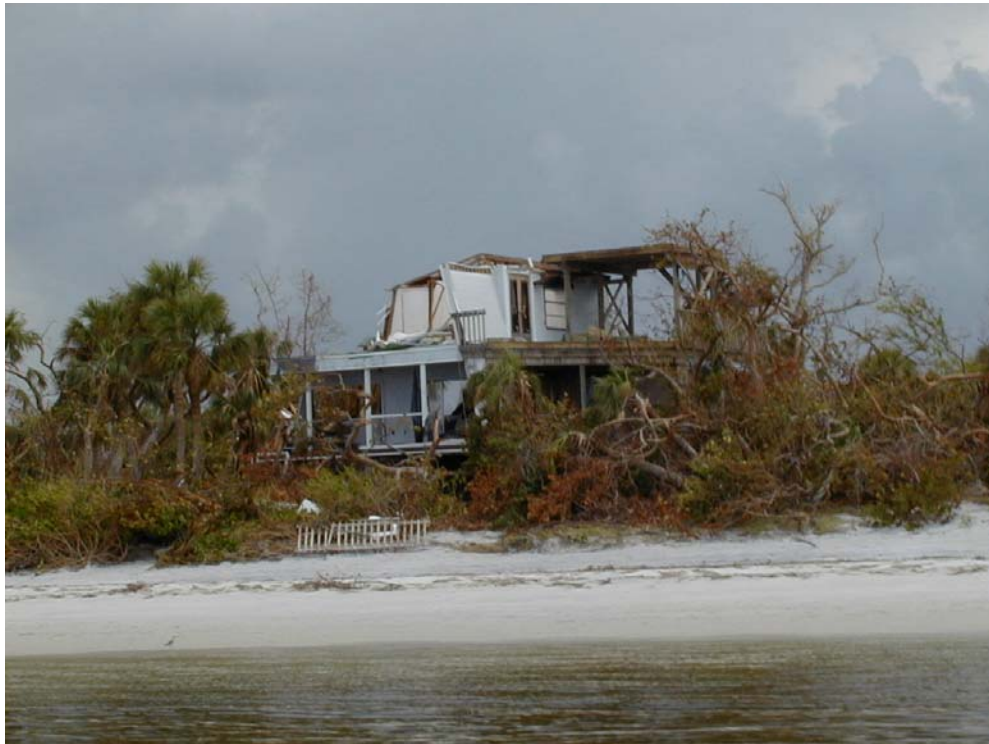
Photo 8. North Captiva Island dwelling destroyed.

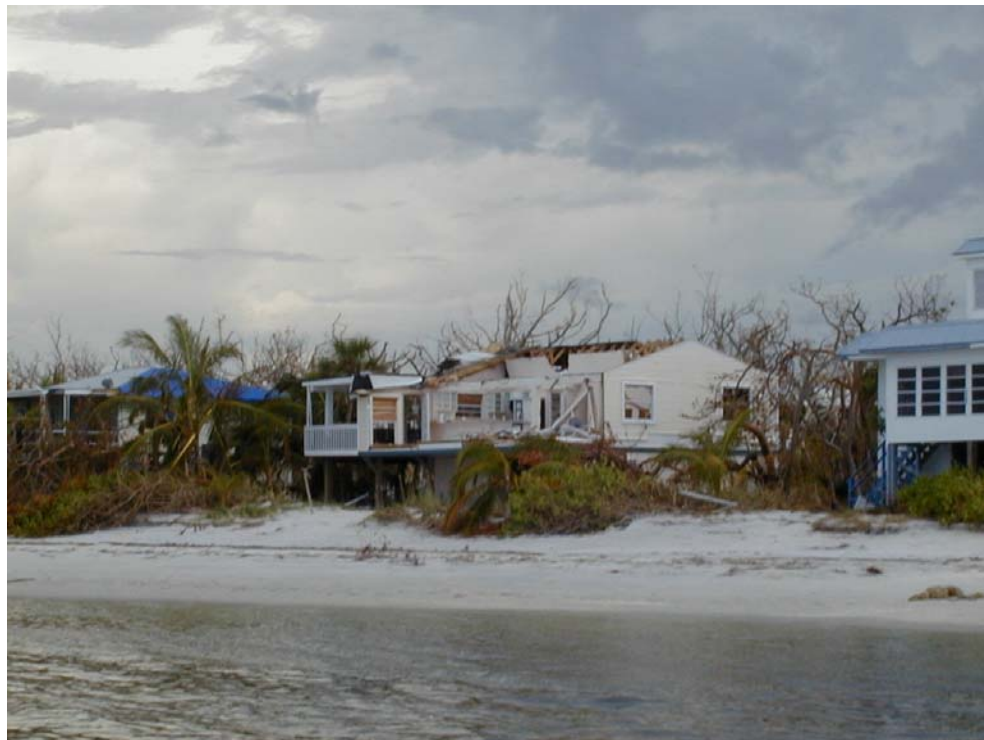
Photo 9. North Captiva Island dwelling destroyed

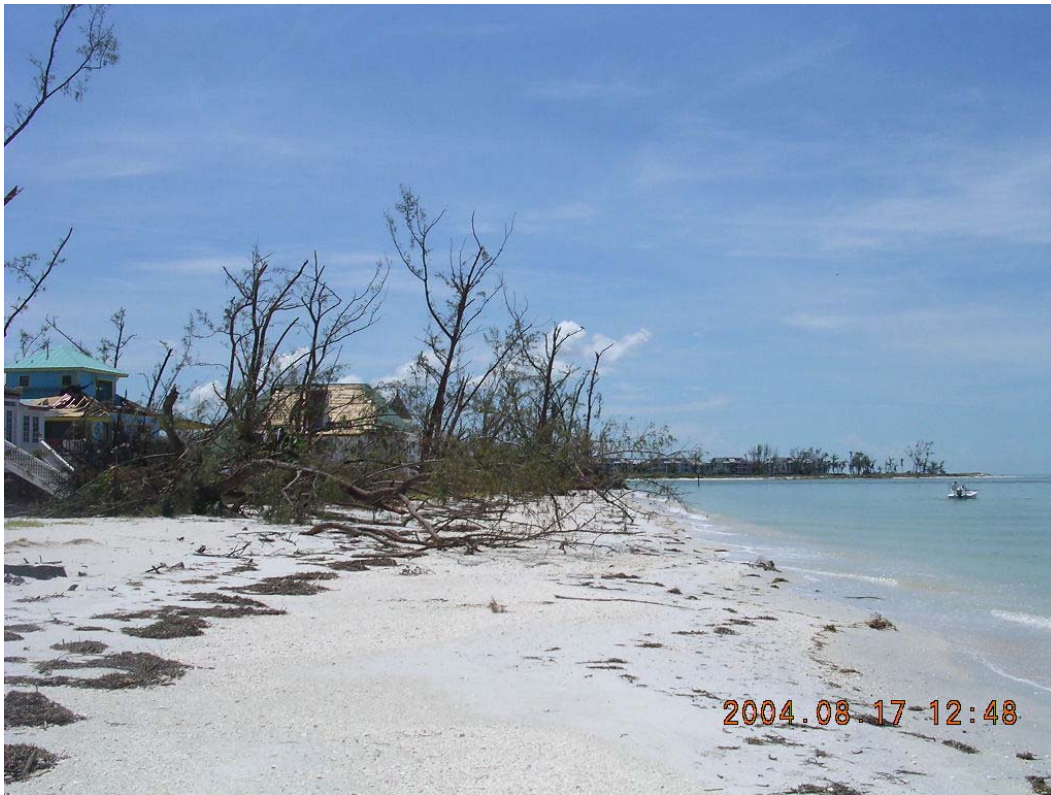
Photo 10. Major beach erosion, North Captiva Island

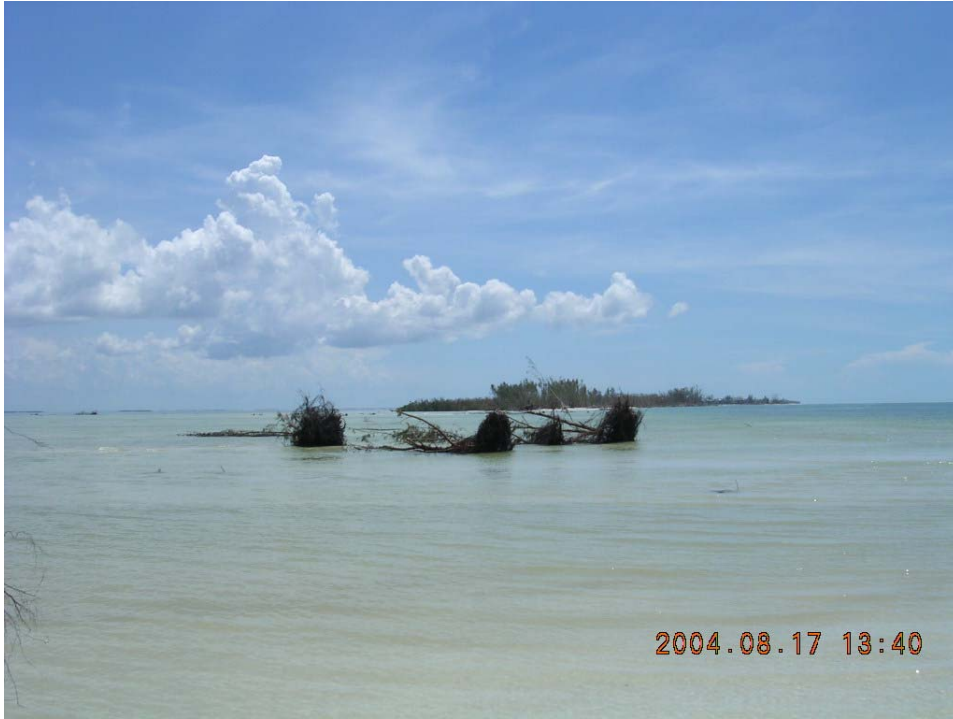
Photo 11. "Charley's Cut" across North Captiva Island (R78-R79)

- Additional shoreline assessment should be conducted when aerial videography is available.
- The new “Charley’s Cut” should be evaluated for its long-term stability and impact on adjoining beaches and Redfish Pass.
- The entire truncated southern portion of the island (R79-R82) should be designated as critically eroded.
- A new management strategy should be developed for the southern 0.8 mile of shoreline (R79-R82).

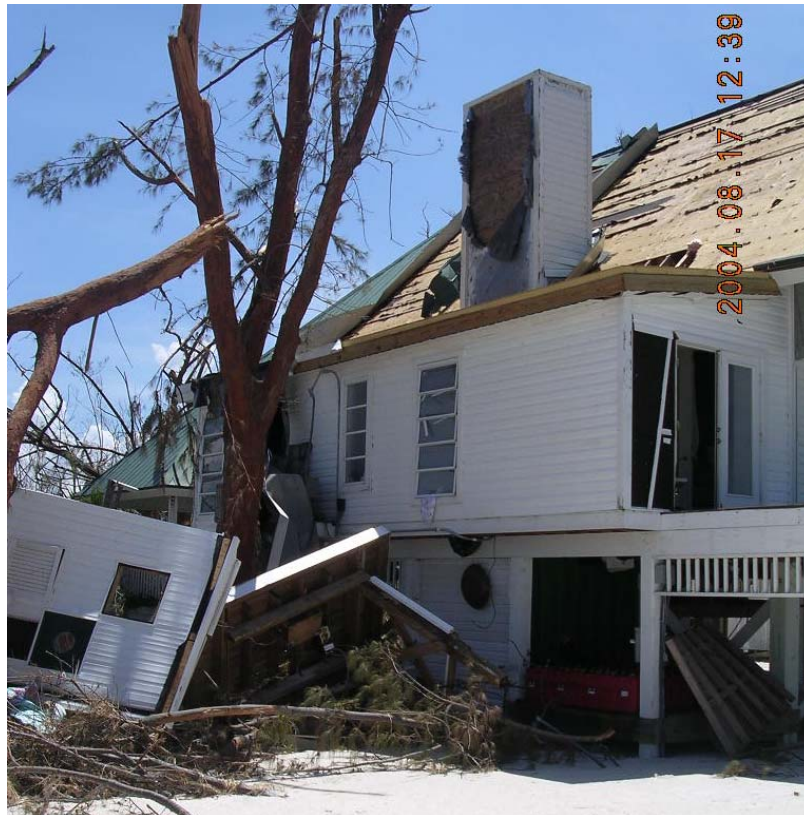
Photo 12. Typical damage at south end of North Captiva Island (R81)

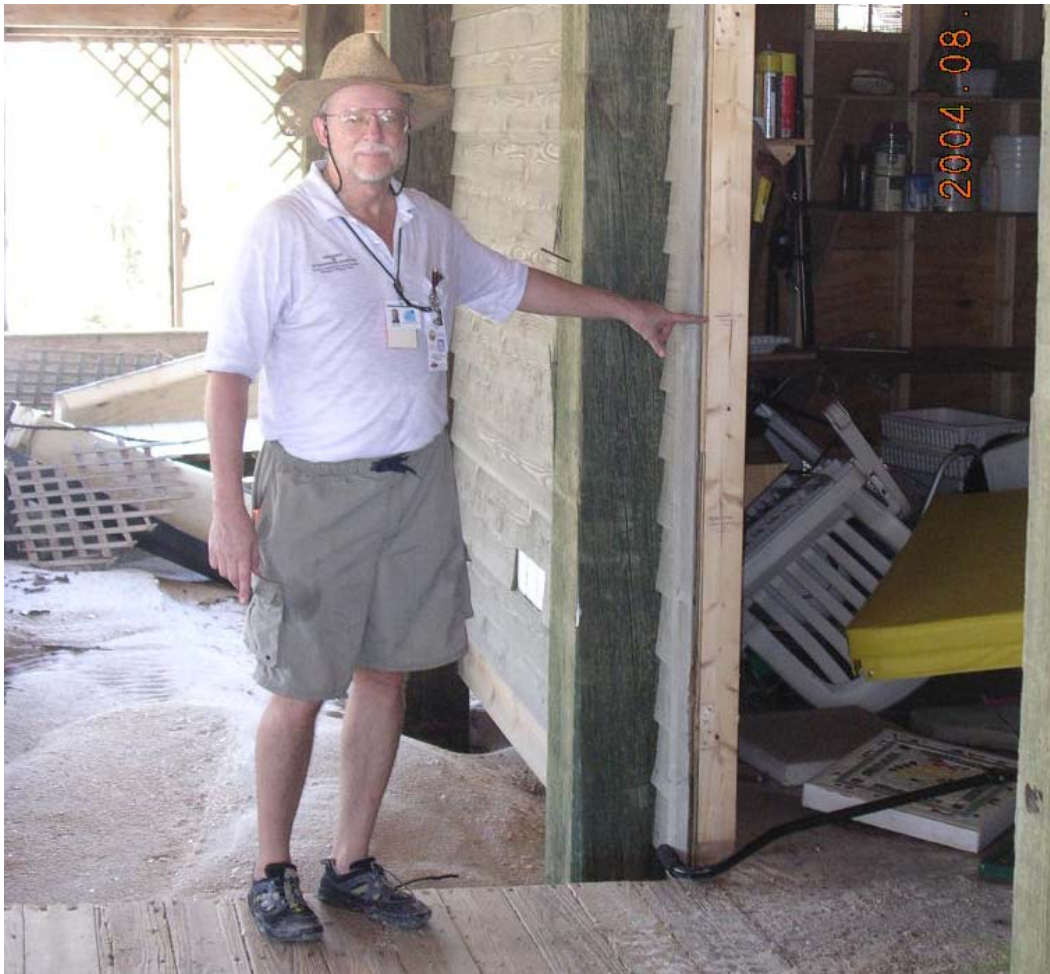
From a water line apparent on an enclosed understructure storage room of one of the dwellings, a storm surge of +9 feet was estimated (Photo 13).

Photo 13. Storm surge elevation of approximately +9 feet on North Captiva Island

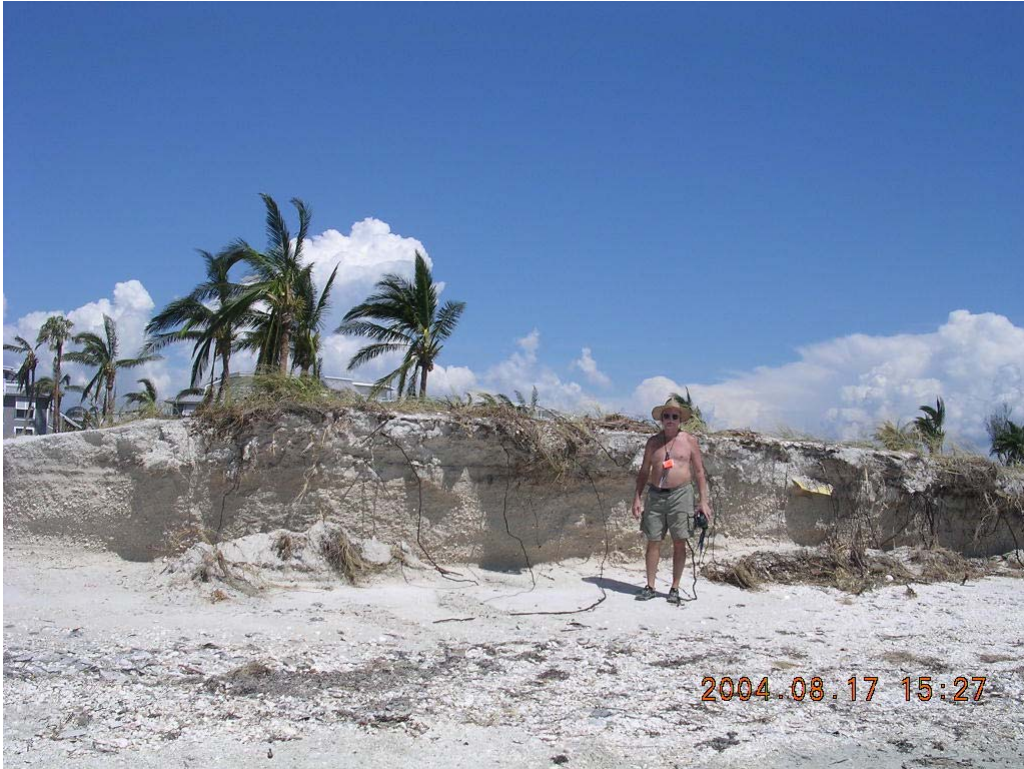
Photo 14. Condition IV erosion, Captiva Island (R84)

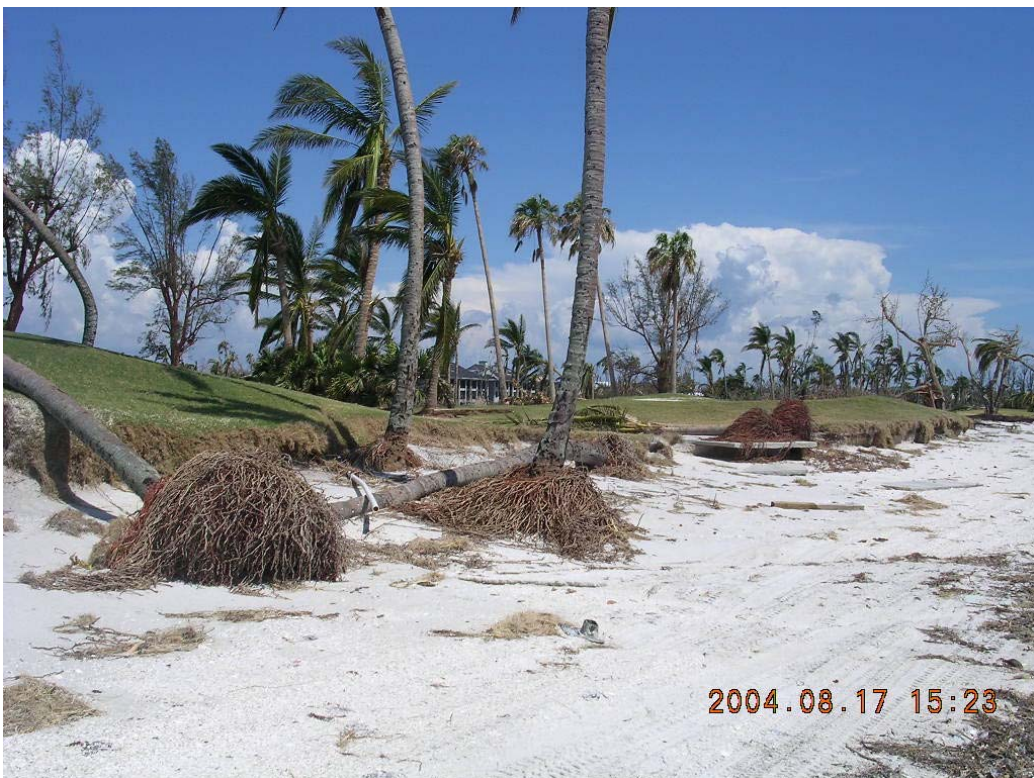
Photo 15. Major beach and dune erosion, South Seas Plantation (R85)

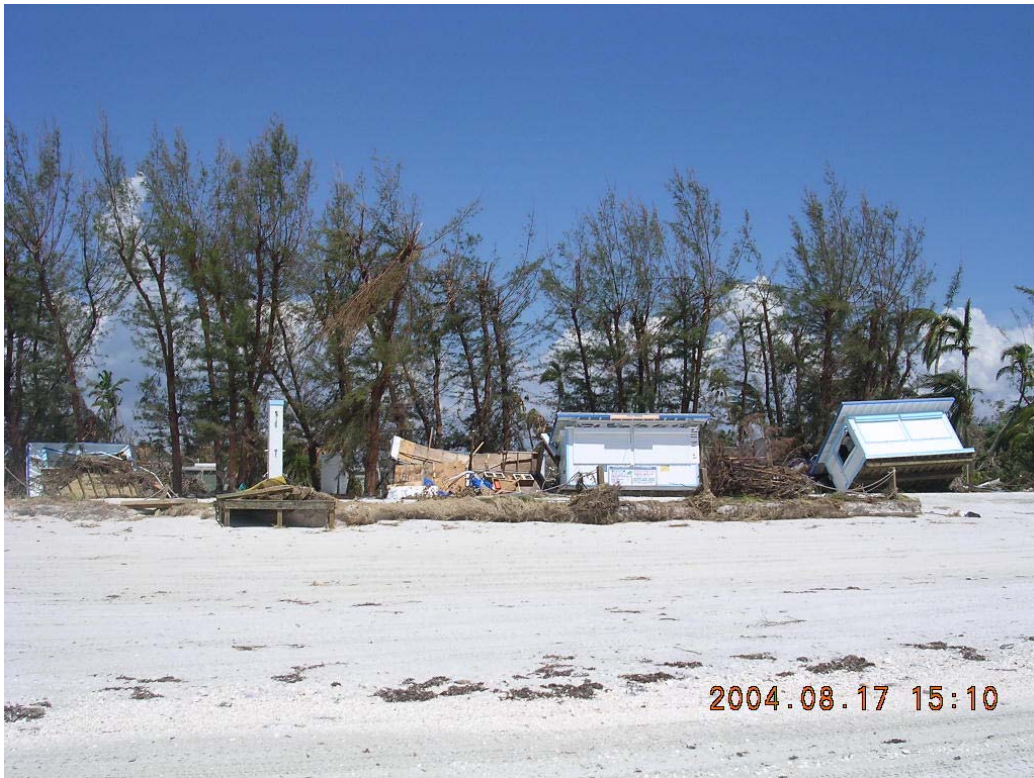
The South Seas Resort at the north end of Captiva Island sustained severe wind damage and significant flooding throughout the development. A storm surge was estimated to have reached between +7 and +8 feet. The northern area of the Resort fronting on the golf course sustained major beach and dune erosion (Condition IV) between R84 and R86 (Photos 14 and 15). A seaward segment of Redfish Pass shoreline revetment sustained damage from the storm surge and storm waves, and the terminal groin at R84 appears to have been completely destroyed. Between R83 and R84 at least 14 out of 17 multifamily dwelling structures sustained major damage primarily to roofs. At least five other buildings near R85 between the golf course and the marina sustained major roof damage. Overall within the Resort extensive wind and flooding damage was sustained by shrubs and trees, utility lines and poles, signs, minor structures (fences, walkways, restrooms, etc.), marina facilities, and recreation structures (tennis court facilities, club houses, golf cart paths, fairways, etc.)(Photo 16).

Photo 16. Typical flood damage, Captiva Island (R86)

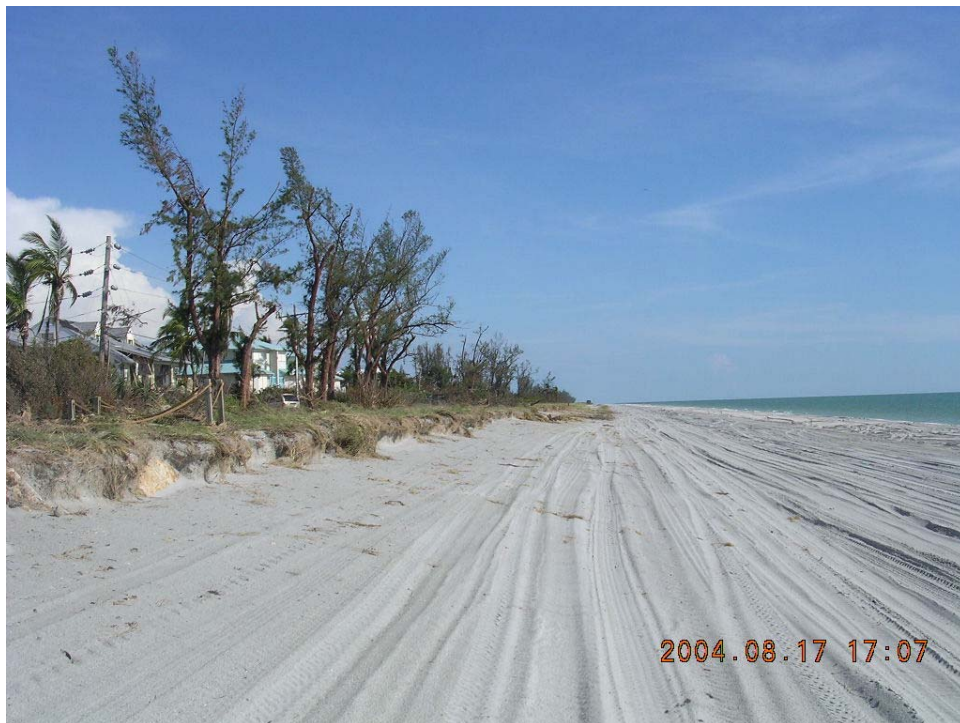
Along the remainder of Captiva Island (R86-R109) minor beach and dune erosion (Condition II) prevailed (Photo 17). The beach restoration project functioned well to mitigate any major storm surge or wave damage. Had the beach restoration project not existed it is highly probable that Captiva Drive between R96 and R101 would have been substantially damaged.

Photo 17. Minor beach and dune erosion, Captiva Island (R97)

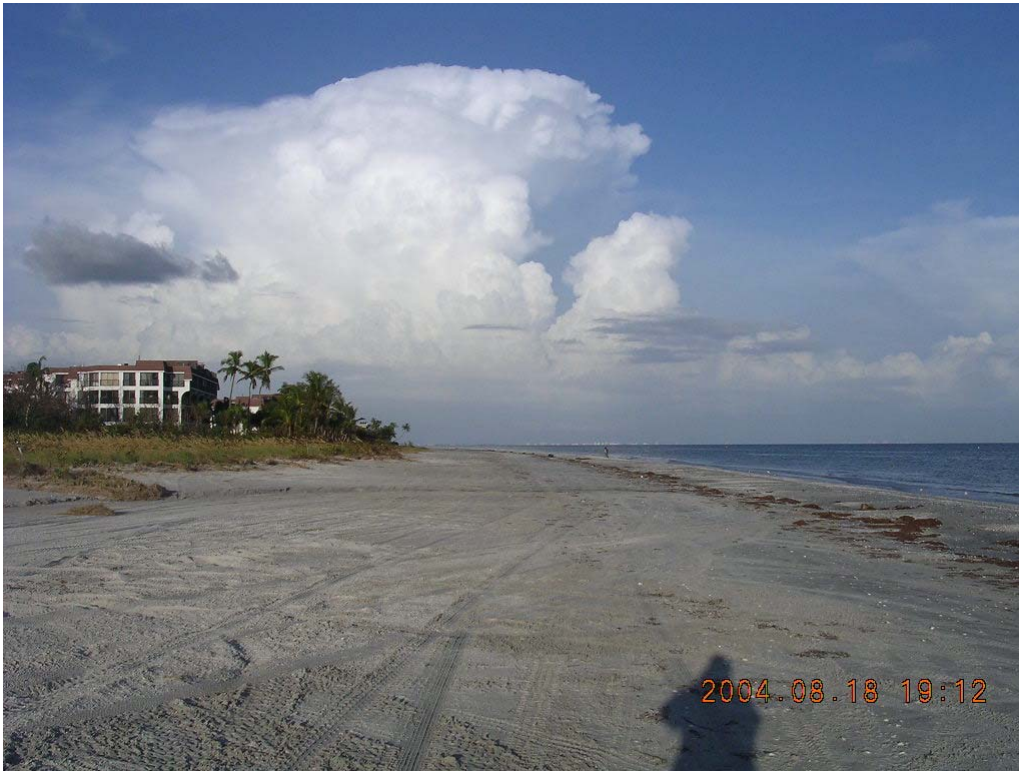
Throughout the remainder of Sanibel Island (R119-R174) minor beach and dune erosion (Condition II) was generally observed (Photo 18). Extensive wind damage was sustained throughout Sanibel Island to shrubs and trees, minor structures, signs, utility lines and poles, and roofing.

Photo 18. Minor beach and dune erosion, Sanibel Island (R165)

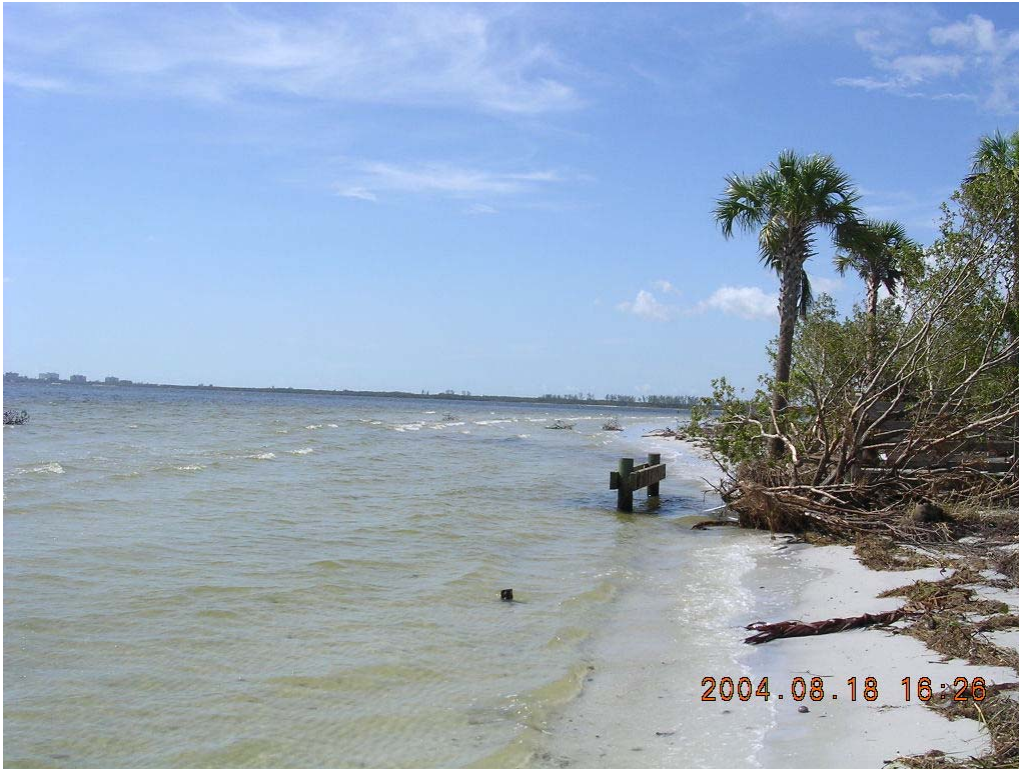
Major beach and dune erosion (Condition IV) was sustained along the north end of Estero Island (R175-R177). At Bowditch Point Park the shoreline receded an estimated 50 to 75 feet (Photo 19). No beach exists at high tide between R175 and R176. Between R176 and R180, grade level commercial and residential development was flooded by a storm surge estimated at +6 to +7 feet. The public beach at Times Square north of the fishing pier also experienced dramatic recession.

Photo 19. Major beach erosion, Bowditch Point (R176)

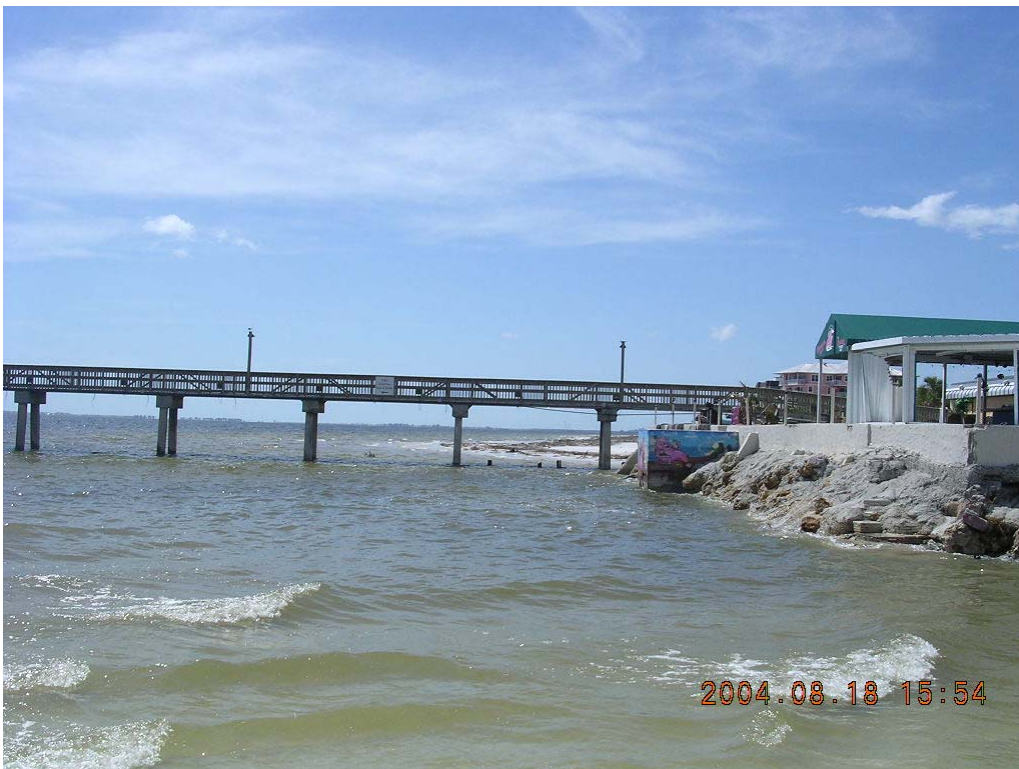
The shoreline receded between 150 and 200 feet at and immediately south of the Ft. Myers Beach Pier (R181). No beach exists at the pier; however, the pier did not appear to sustain any significant damage (Photo 20). Three Gulf-front commercial buildings at R181 sustained major roof damage and two other commercial buildings sustained major side damage. A pool house was also destroyed.

Photo 20. Major beach loss adjacent Ft. Myers Beach Pier (R181)

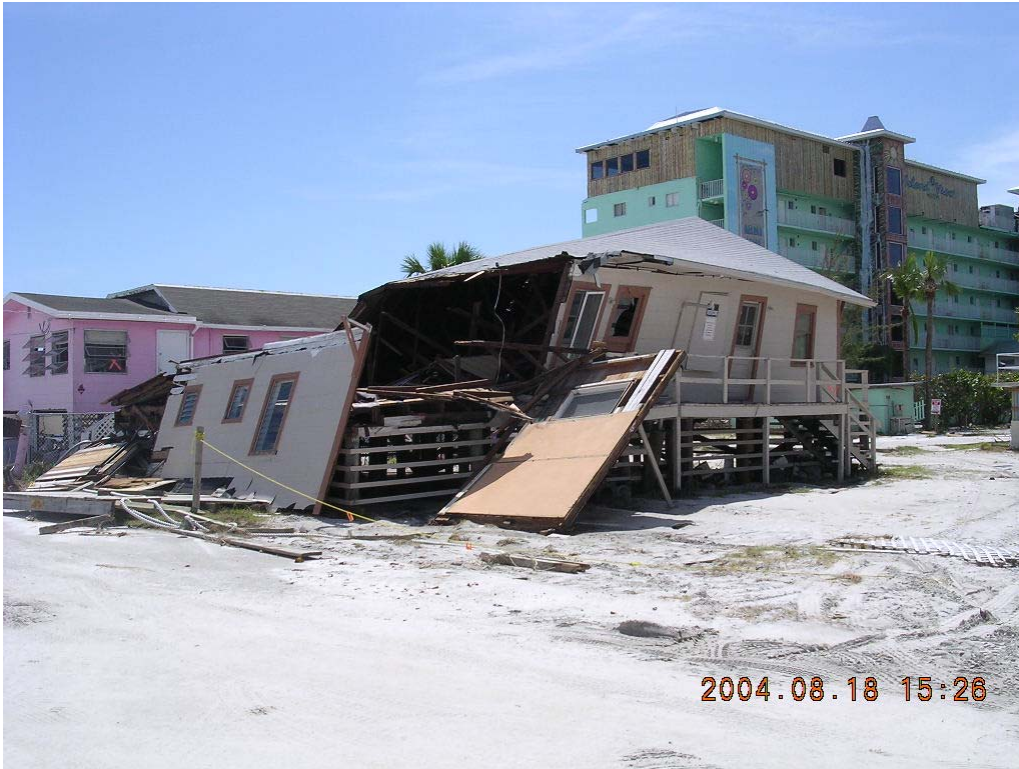
Between R182 and R184 a wide beach remains that saw an estimated two feet of vertical scour. One single-family dwelling located 300 feet north of R183 (Photo 21) was totally destroyed. A large commercial building (hotel and restaurant) sustained major first floor damage and was gutted by flooding on the interior. In addition, four single-family dwellings and three multifamily dwellings sustained major roof damage. Numerous structures in this area (R182-R184) sustained flooding damage as well as roofing and siding damage.

Photo 21. Estero Island dwelling destroyed (R183)

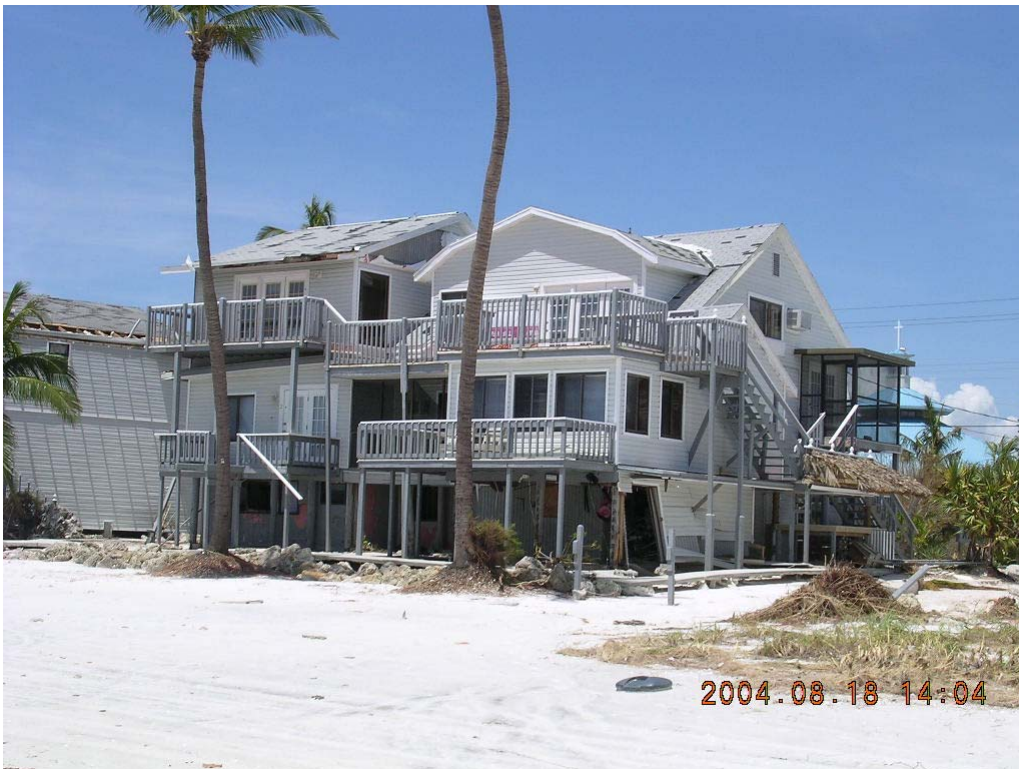
Between R187 and R192, major beach and dune erosion (Condition IV) was observed. Along this hard hit segment of Estero Island, eleven single-family dwellings had major first floor damage (Photo 22), sixteen single-family dwellings had understructure damage, and three single-family dwellings had major roof damage. About 450 feet north of R190 a 100-foot long wood retaining wall with a 20-foot return and a concrete cap was damaged.

Photo 22. Estero Island dwelling with typical flood damage (R191)

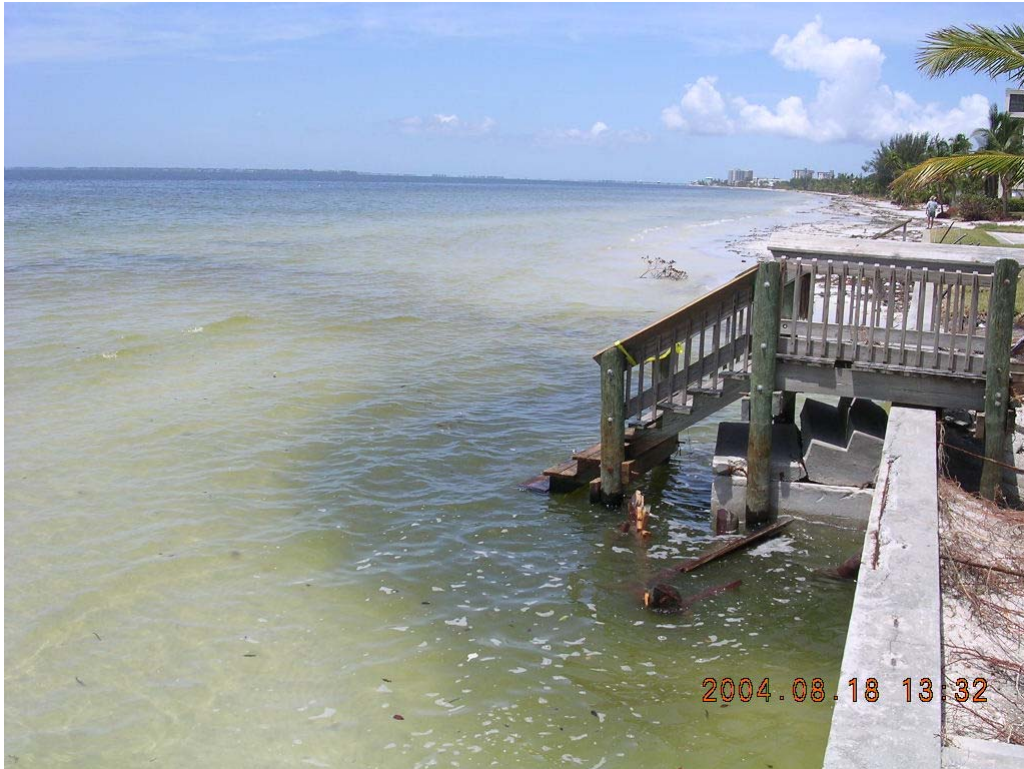
Between R192 and R196 is a segment of shoreline that is armored with concrete seawalls and rock revetments. This armored stretch of shoreline sustained major beach erosion (Condition IV). No beach remains along this stretch as the shoreline receded between 50

Photo 23. Beach lost seaward of armoring (R192)

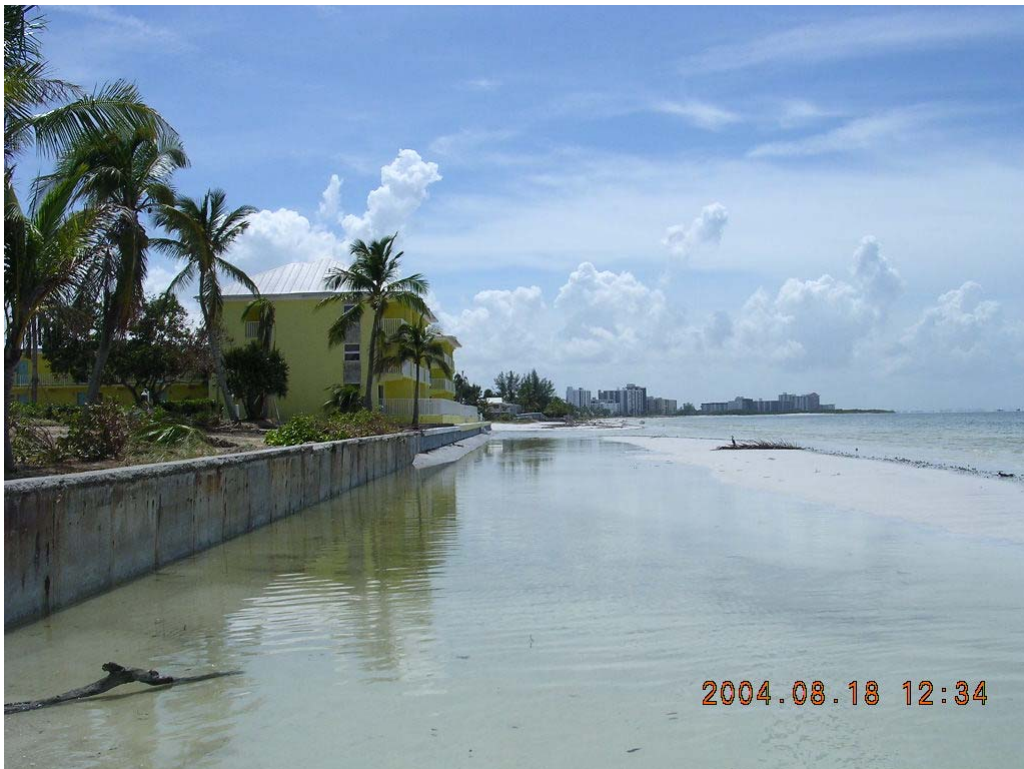
and 100 feet (Photo 23). The beach scoured a maximum of about 4 to 5 feet vertically immediately seaward of the armoring leaving a pronounced scour trough aligned parallel with the seawalls (Photo 24). Conditions appeared similar to the scour trough left by Hurricane Elena in 1985 along the Sand Key seawalls in Pinellas County, except no major damage was apparent to these Estero Island walls.

Photo 24. Scour trough with sandbar formation seaward of armoring (R195)

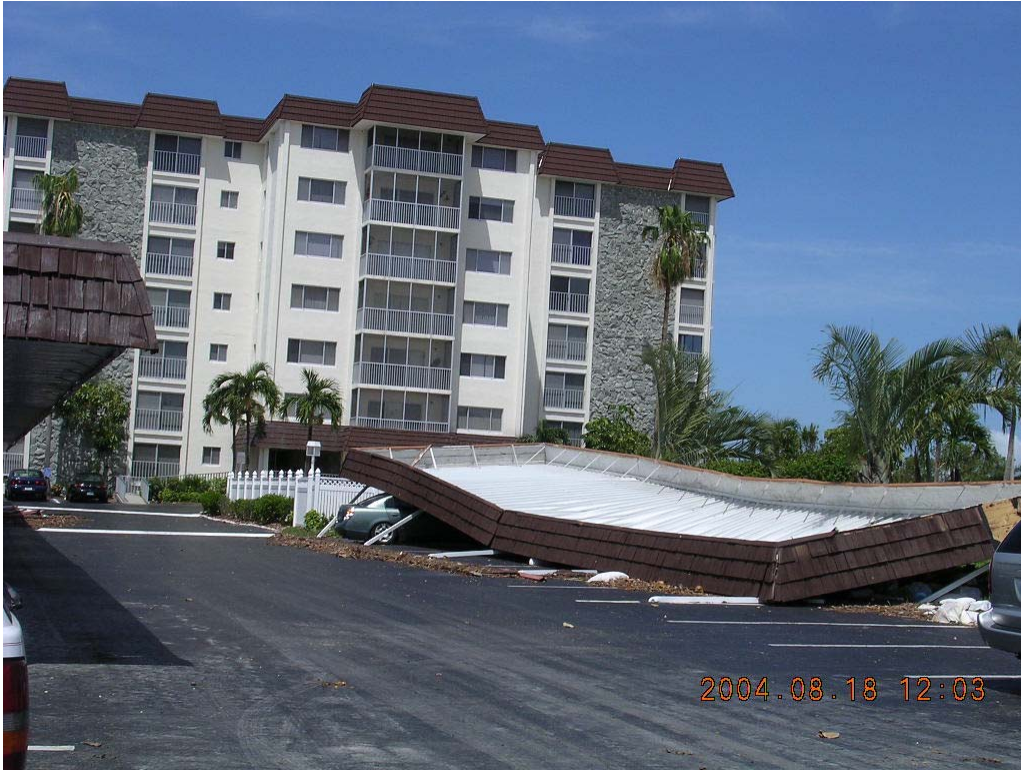
Photo 25. Typical canopied parking structure destroyed (R202)

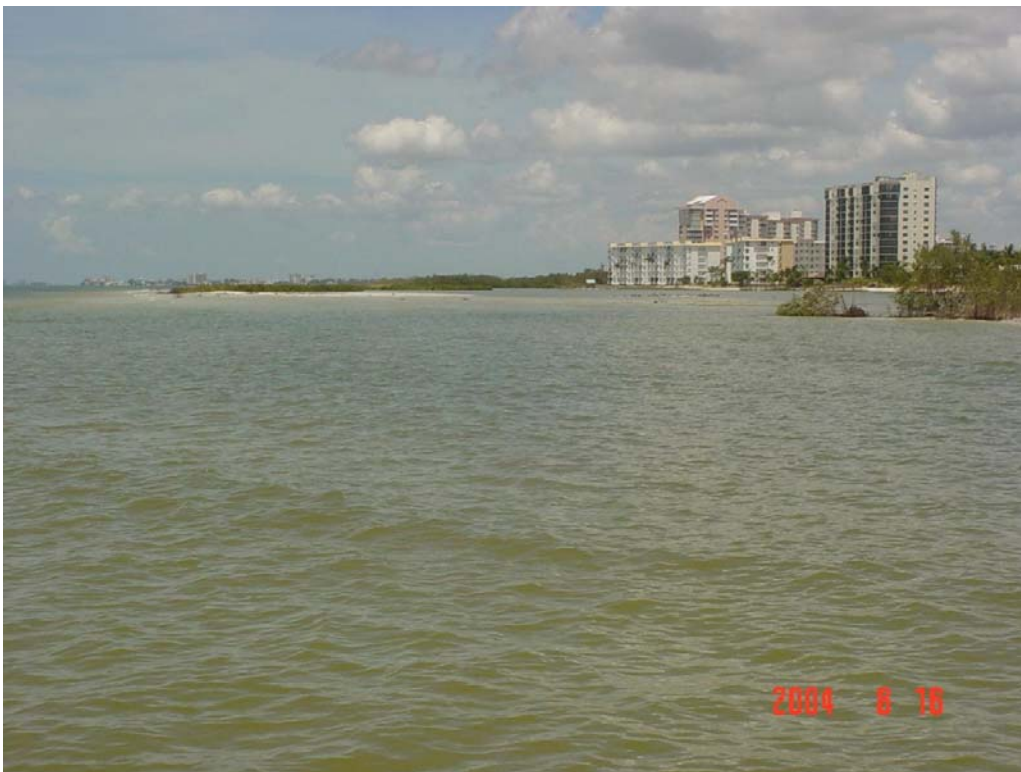
Photo 26. Barrier breach on south Estero Island in the vicinity of R206
(Photo by Robert Neal, Lee County Department of Natural Resources)
