HURRICANE CHARLEY

**Post-storm Beach Conditions and Coastal Impact Report
with
Recommendations for Recovery and Modifications of Beach
Management Strategies**

**Florida Department of Environmental Protection
Division of Water Resource Management
Bureau of Beaches and Coastal Systems
August 2004**

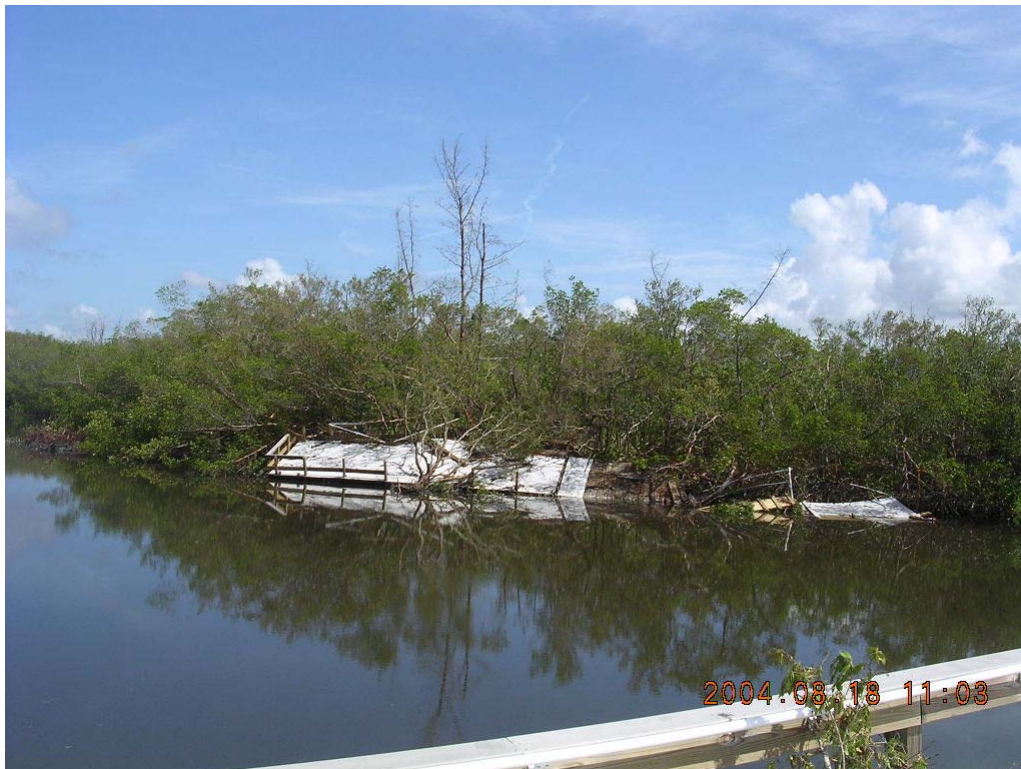
Photo 27. Pedestrian bridge destroyed at Lovers Key State Park (R217)

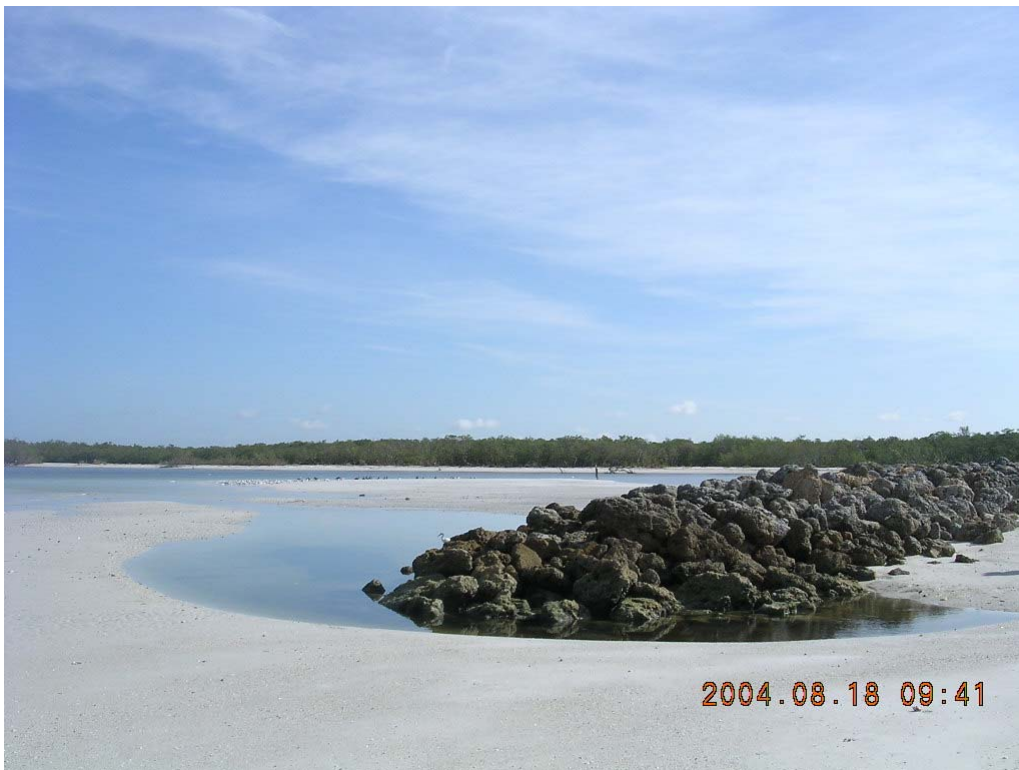
At the south end of the island, Big Hickory Pass remains open, but additional sand was transported into the pass off Bonita Beach. Three dominant sandbars are exposed at low tide representing the bypassing bars of the inlet (Photo 28).

Photo 28. Scour hole and bypassing bars, Big Hickory Pass (R226)

- Continued monitoring of the beach and Big Hickory Pass is recommended.

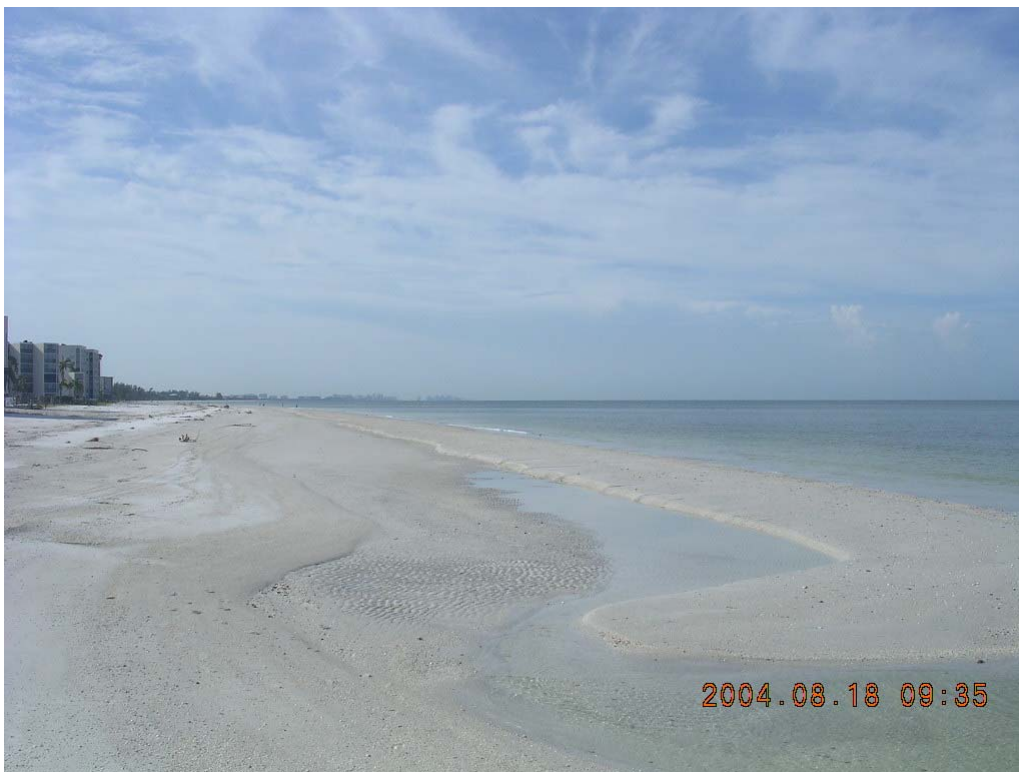
Photo 29. Minor erosion of Bonita Beach (R227)

- The nourishment project's erosion losses should be evaluated and the feasibility of fill replacement should be considered while the dredge equipment conducting the Lover's Key beach restoration project remains in the vicinity.
