## Monroe County

### **Storm Effects and Erosion Conditions**

### **Storm Damage**

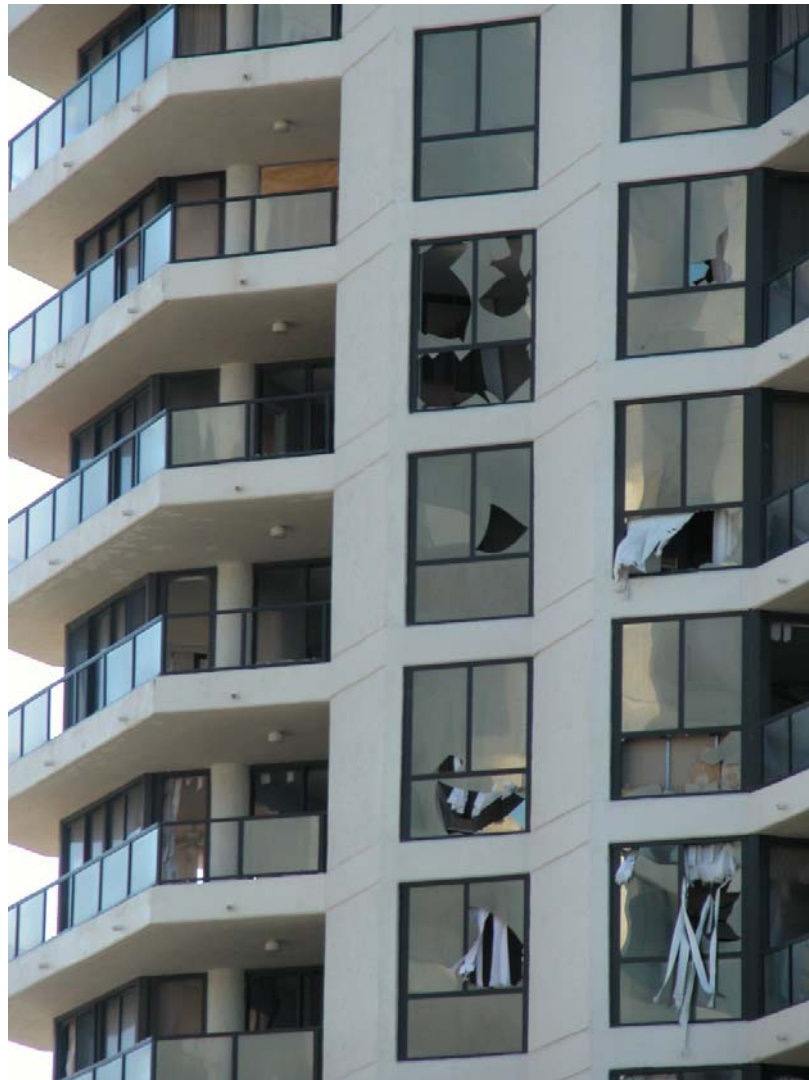
At the south end of Marco Island, nine high rise condominiums sustained minor wind damages, to include, broken windows, torn or destroyed screen porch enclosures, and damaged storm shutters (Photo 17). Five single-family dwellings and 12 high rise condominiums sustained major wind damages to some of their units or to their roofing (Photo 18). One condominium sustained understructure damage due to the storm surge and three carports were destroyed. Landward of the Coastal Construction Control Line within the Coastal Building Zone numerous single-family dwellings sustained minor to major wind damages.

Photo 17. Window damage to high-rise condominium (R145.3).

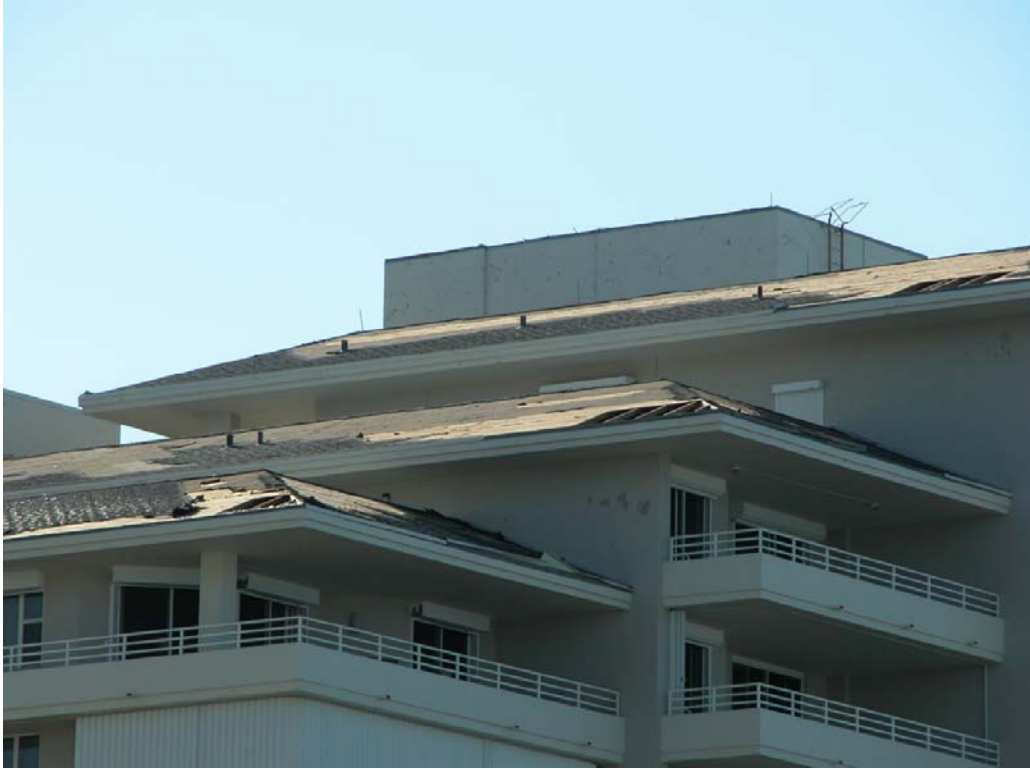
Photo 18. Major roof damage, Marco Island (R145.4).

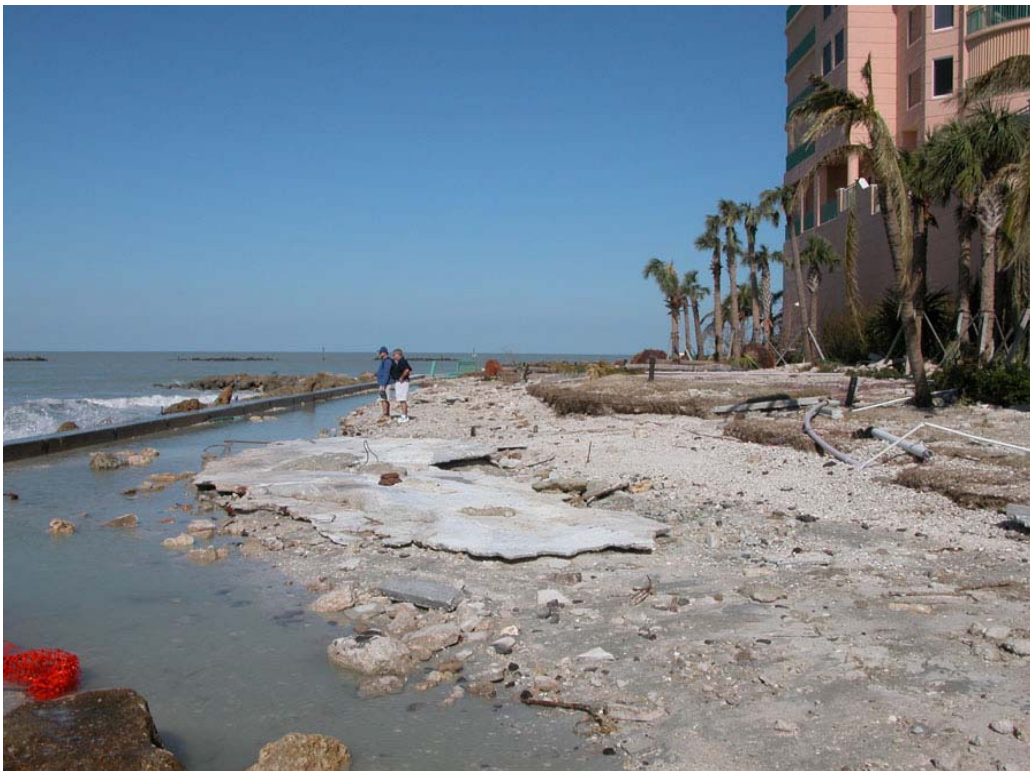
At the southwest tip of Marco Island an existing seawall and revetment sustained level two damage (Photo 19). Several tie backs were damaged and the wall was overtopped, losing a significant amount of material between the wall and the buildings. Along the north segment of the seawall, a discharge gully was cut, eroding the dune structure, and allowing the storm surge to flood and sand a swimming pool.

Photo 19. Seawall and revetment overtopped and damaged, south end of Marco Island.

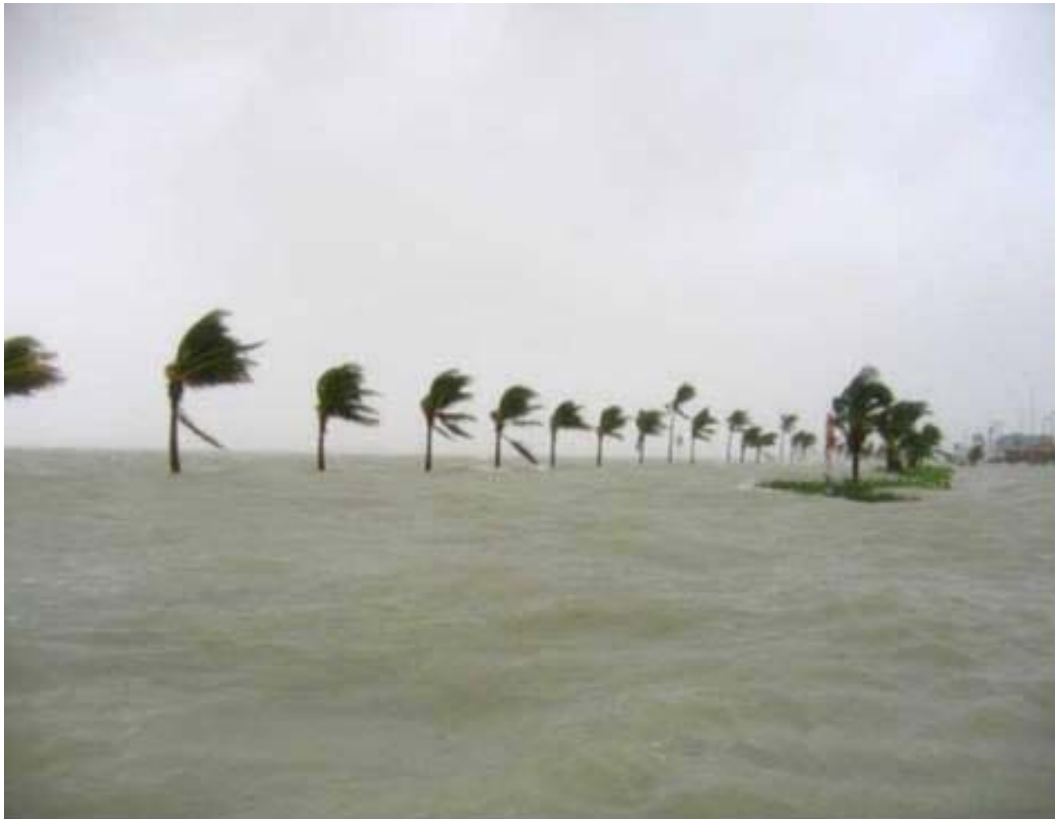
Wilma brought storm tides estimated to reach approximately 10 feet along the northern gulf coast of Monroe County affecting the Florida Everglades National Park. Storm tides of eight to ten feet inundated the lower and middle keys, with the highest storm surge affecting the keys from the Gulf of Mexico and Florida Bay sides of the islands. Roughly 35 percent of the island of Key West was flooded, including the airport, which had five feet of water at its entrance and three feet of water on the runway. Photos 20-22 depict the storm surge flooding in Key West.

Photo 20. North Roosevelt Boulevard, Key West (Credit: City of Key West).

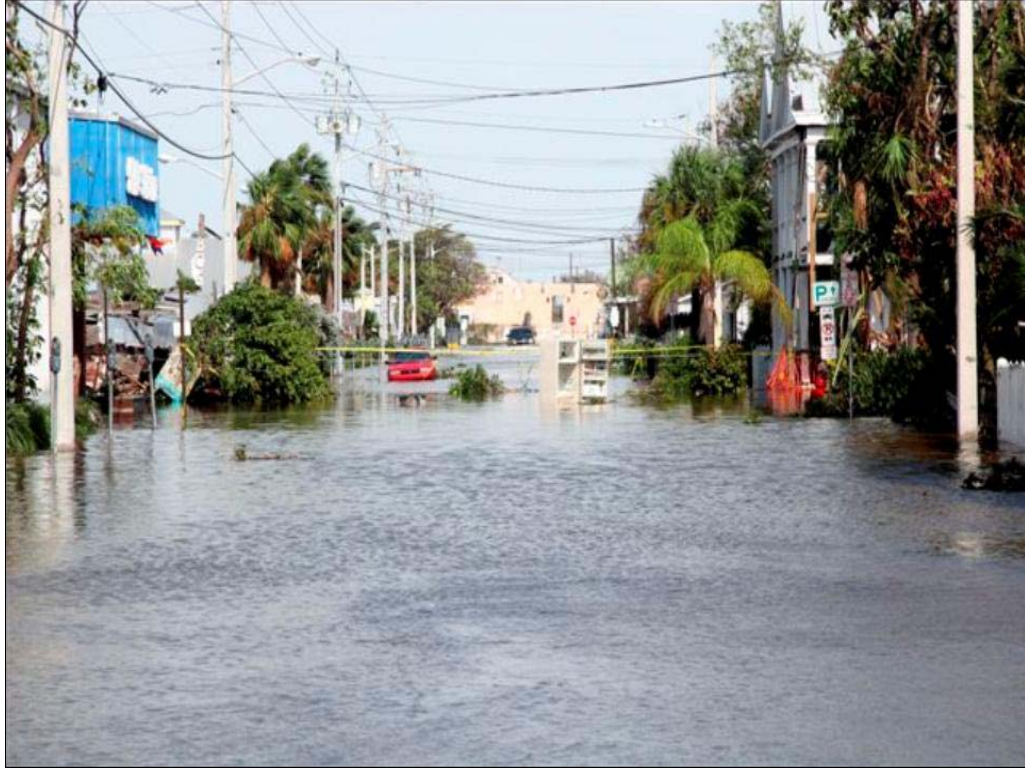
Photo 21. Key West flooding (Credit: City of Key West).

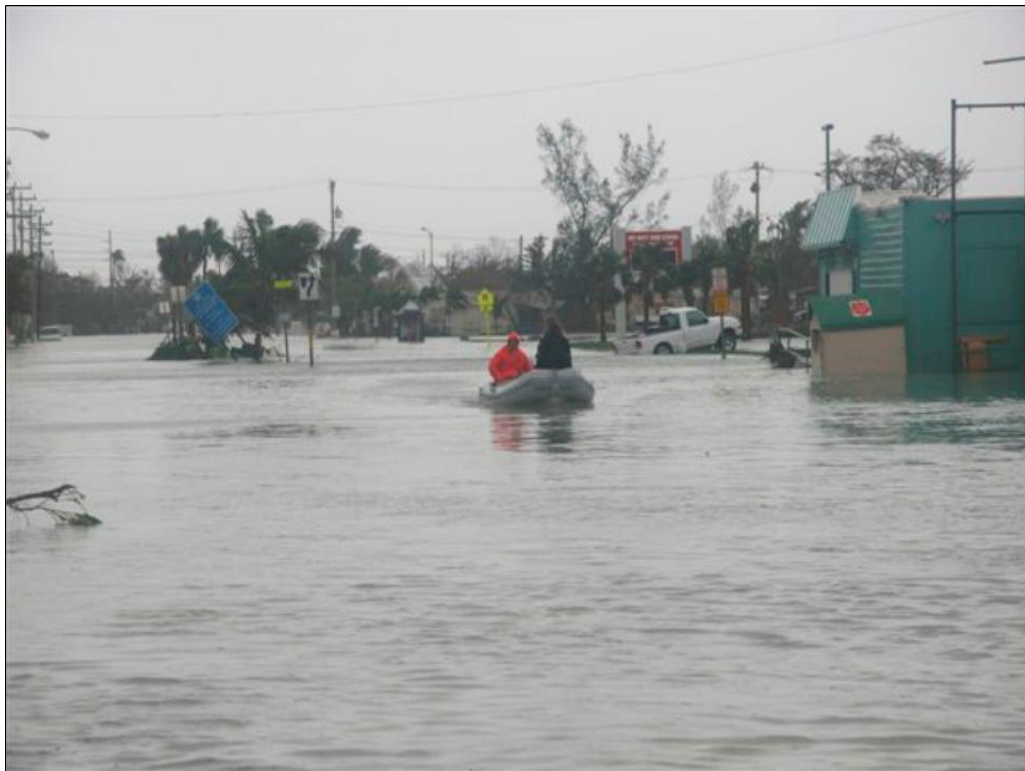
Photo 22. Key West flooding (Credit: City of Key West).

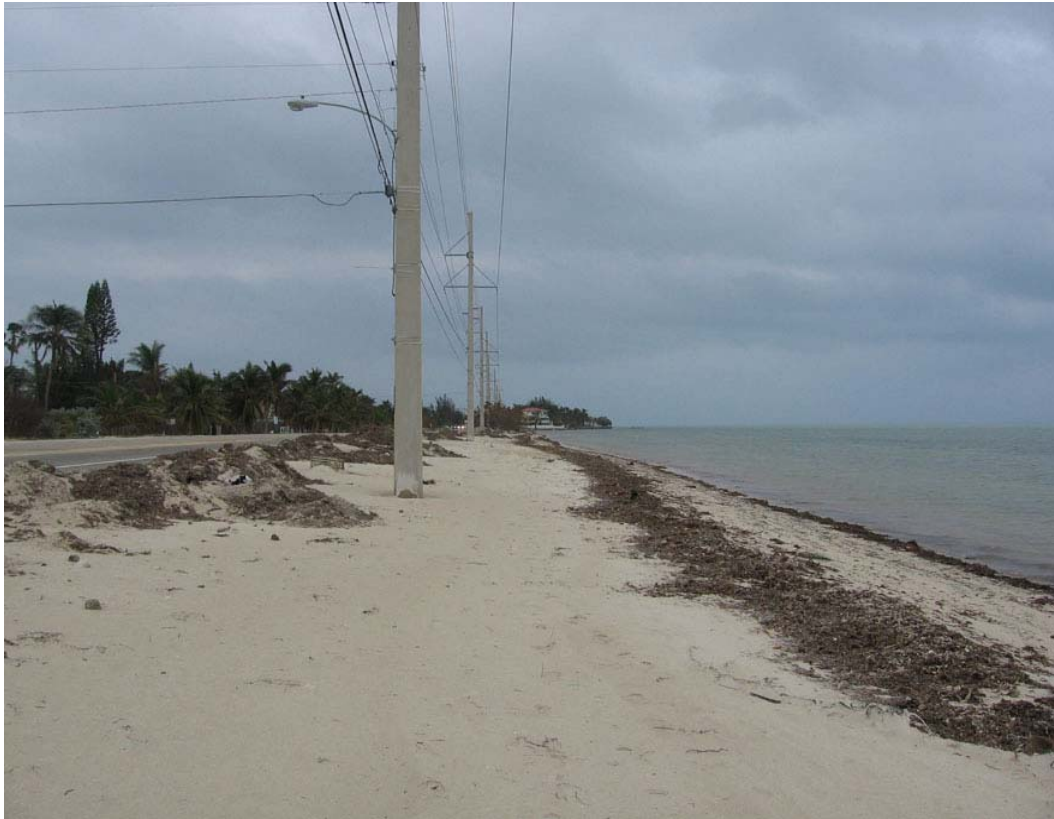
Upper and Lower Matecumbe Keys sustained significant flooding from Florida Bay. Sea Oats Beach along Lower Matecumbe Key sustained additional moderate beach and dune erosion (condition III) (Photo 23). Hurricane Wilma's surge and waves from the Straits of Florida overwashed U.S. Highway 1, pushing debris and sand across the road.

Photo 23. Sea Oats Beach, Lower Matecumbe Key (Islamorada).

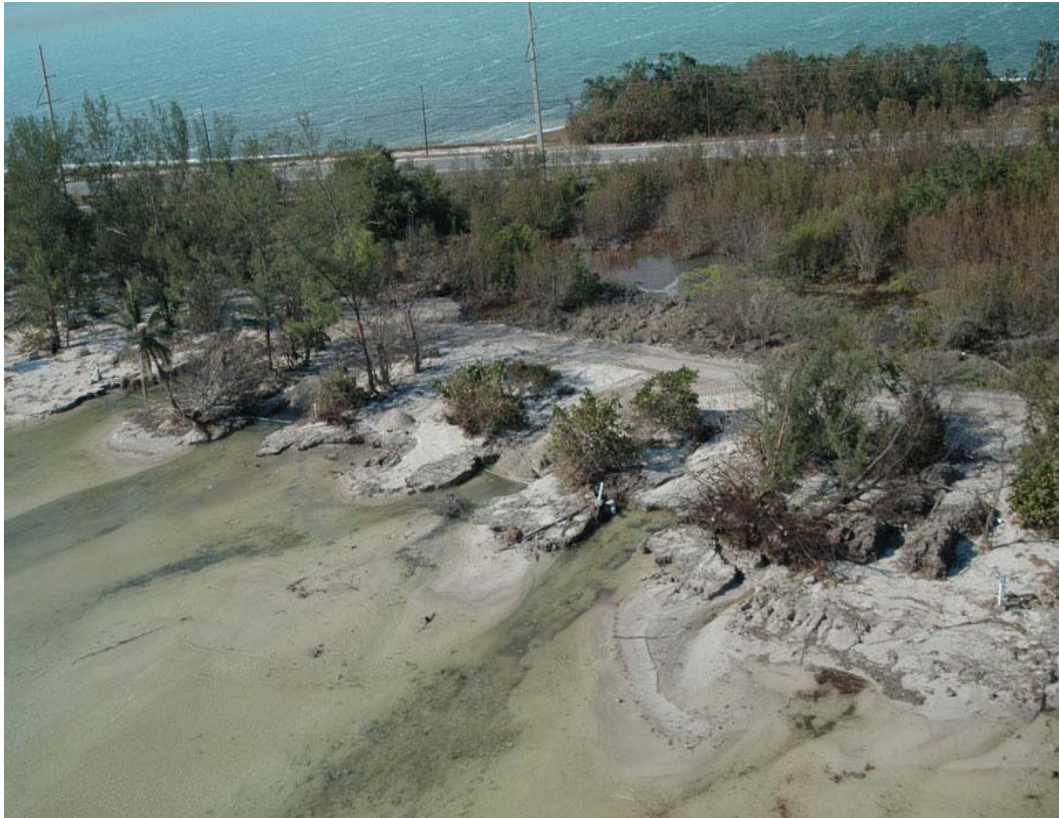
In September, 2005, Hurricane Rita traversed the Straits of Florida and severely impacted the beach along Long Key State Park, destroying all 60 camp sites. Wilma significantly worsened the beach conditions and camp sites. In the early stages of the storm's impact, the surge and waves from the straits were inflicting additional erosional stress to the shoreline and upland areas. As the eye of Wilma passed to the north, the large storm surge from within Florida Bay overtopped the island from the north, and flood waters were conveyed southward across U.S. Highway 1 and the state park. This "back door" flooding caused large scour channels throughout the park's camp grounds and transported beach and overwash sediments seaward into the nearshore waters off the park's beach (Photo 24).

Photo 24. Storm surge scour channels, Long Key State Park.

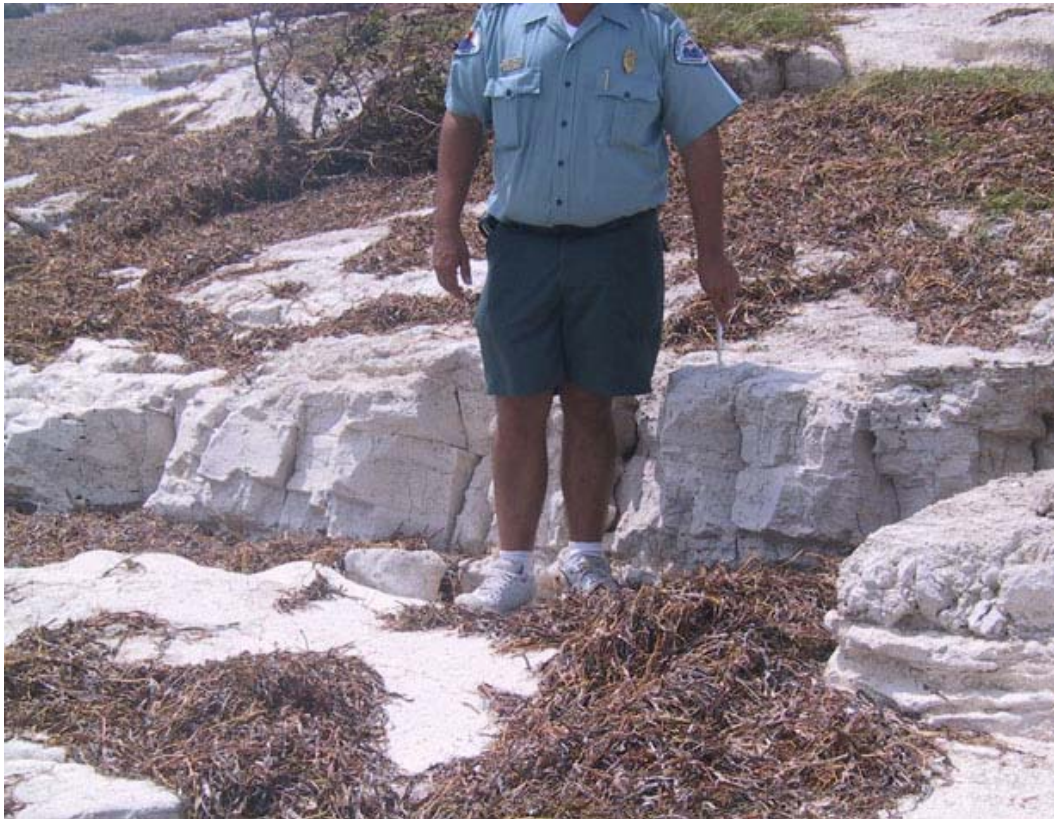
The critically eroded beach conditions at Curry Hammocks State Park substantially worsened. After Hurricane Rita, there was only a small segment of condition II erosion; however, after Wilma most of the park's shoreline had sustained moderate to major erosion (condition III-IV). Most surprising was the significant erosion into what were essentially marl uplands of a former dredge and fill project (Photo 25). A beach restoration project in the planning stages will now have to account for additional quantities of beach fill.

Photo 25. Significant erosion, Curry Hammocks State Park.

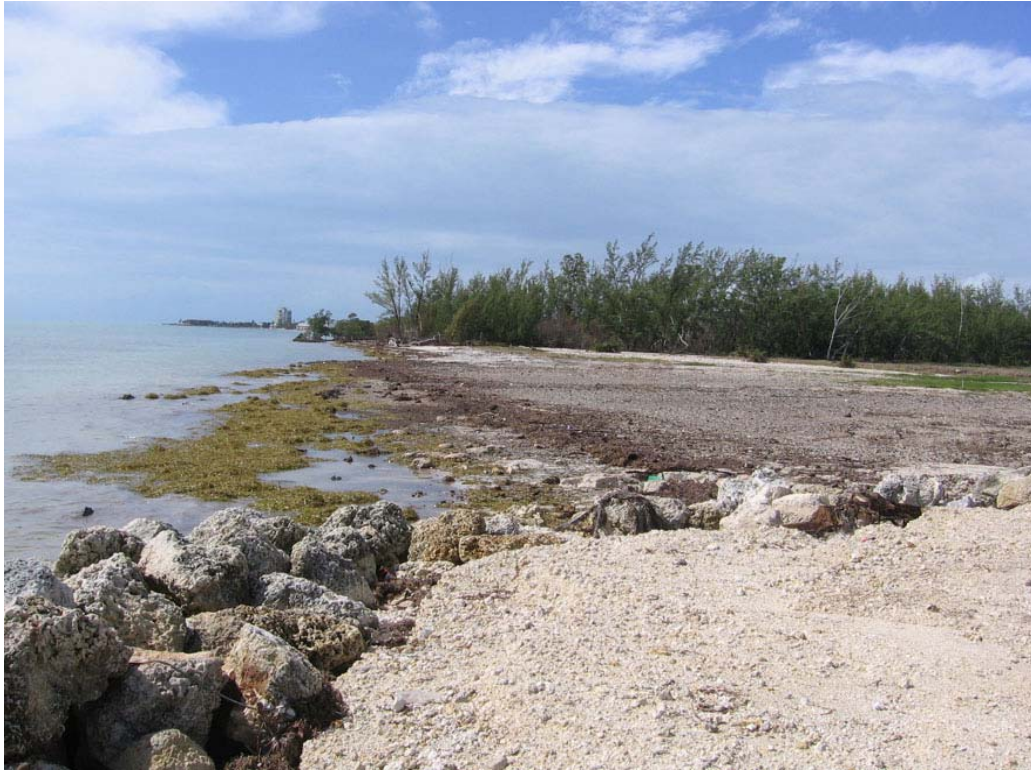
The flooding of Coco Plum Beach was not as severe as many other keys in the vicinity due to its lesser exposure to the surge off Florida Bay. Still, Coco Plum has very low elevations and flooding was significant. Along the developed segment of Coco Plum Beach, which is designated as critically eroded, the erosion conditions varied from minor beach and dune erosion (condition II) at the Coco Plum Beach Villas and Royal Plum Condominium to moderate beach and dune erosion (condition III) along the west end of Coco Plum Beach. The City of Marathon park that traverses the eastern two thirds of Coco Plum Beach sustained additional erosion and overwash of beach sediments into the mangrove wetlands landward of the beach. The extreme east end of the park sustained severe major beach erosion (condition IV) (Photo 26).

Photo 26. Severe beach erosion, Coco Plum Beach.

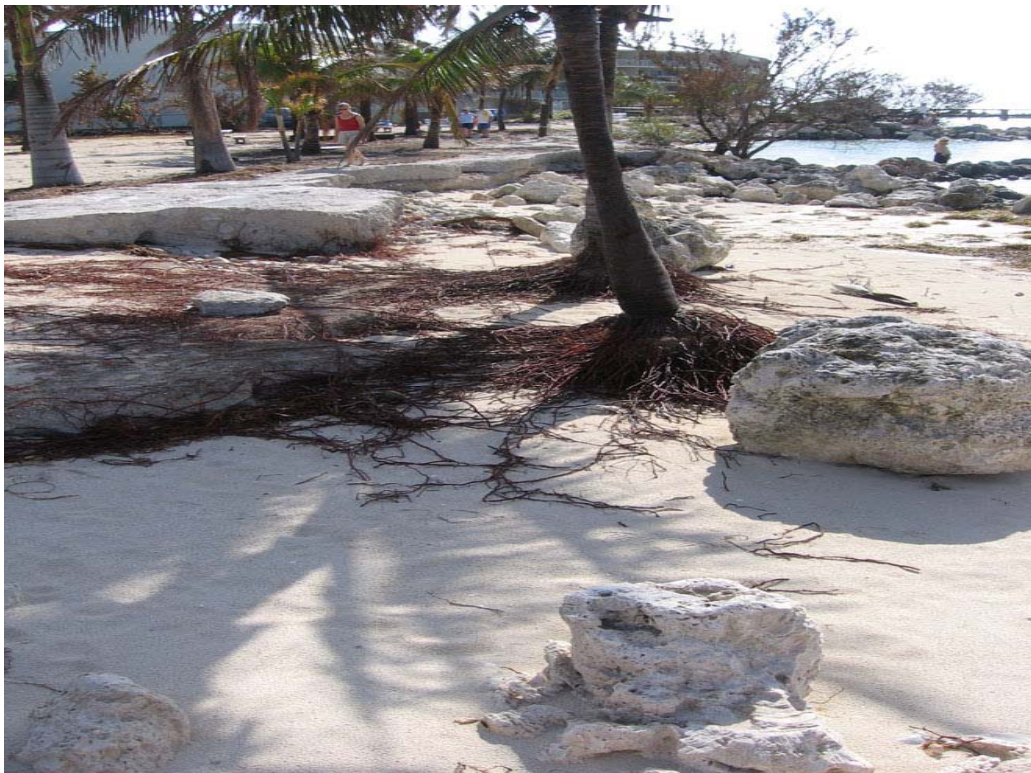
The City of Key Colony Beach sustained less flooding than did Marathon Shores, which was flooded from Florida Bay; however, the flooding was still significant off Hawk Channel. The west shoreline of Key Colony Beach northwest of Sandy Point sustained moderate to major beach and dune erosion (condition III-IV). Sunset Beach, the city's public beach, sustained major erosion conditions into the uplands (Photo 27).

Photo 27. Sunset Beach, City of Key Colony Beach.

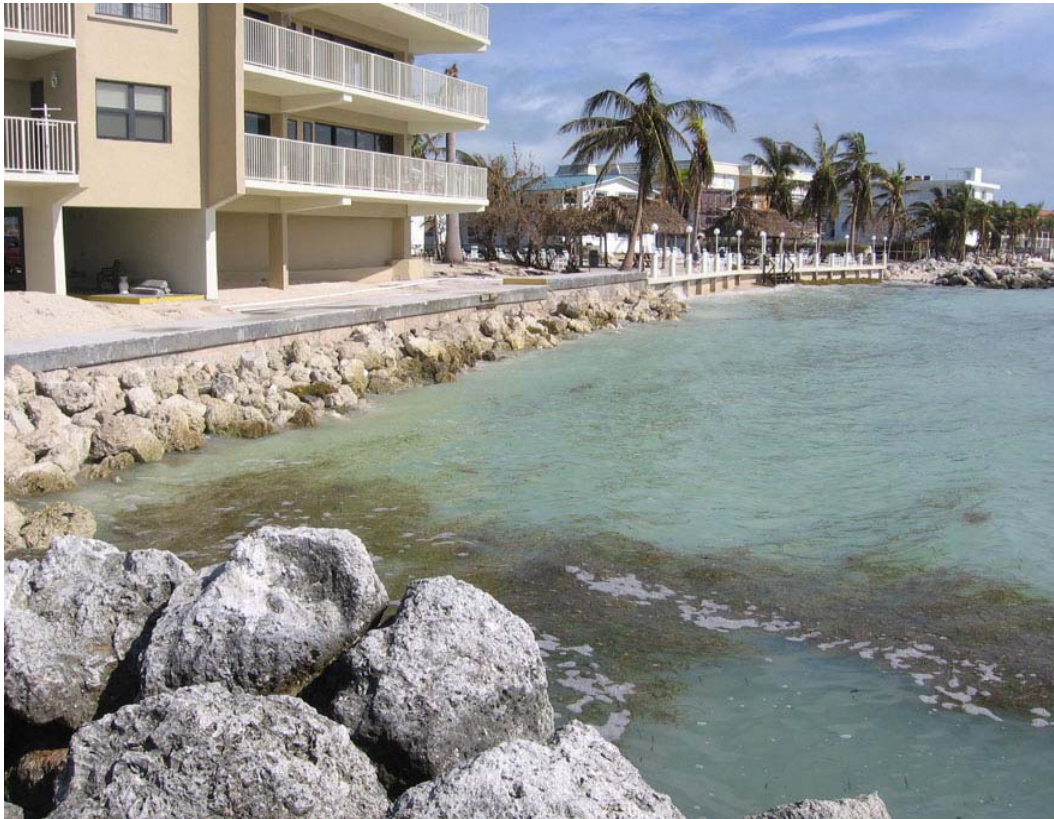
Along the private beaches east of Sandy Point, minor to moderate beach and dune erosion (condition II-III) was sustained. These beaches are within a groin field, and the cumulative erosion conditions since Hurricanes George (1998) and Irene (1999) have severely reduced their recreational and storm protective values. The segment of beach at the Key Colony Point Condominiums has been totally lost seaward of the seawall that fronts the development (Photo 28).

Photo 28. Complete loss of emergent beach at Key Colony Point, Key Colony Beach.

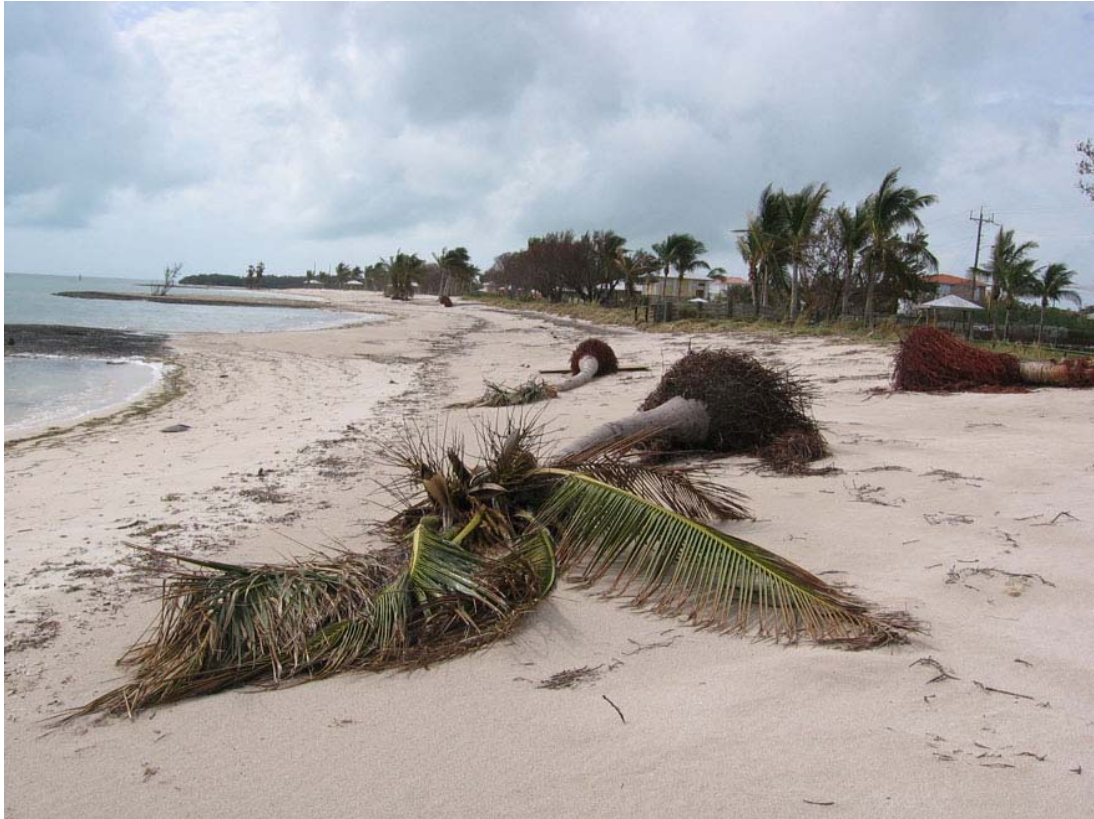
Significant overwash from four hurricanes has caused minor to moderate beach and dune erosion (condition II-III) along the City of Marathon park at Sombrero Beach (Photo 29). Additional sediment losses have occurred as the southwest waves have driven beach material into the Tingler Island canals as well as the nearshore.

Photo 29. Sombbrero Beach erosion, Marathon.

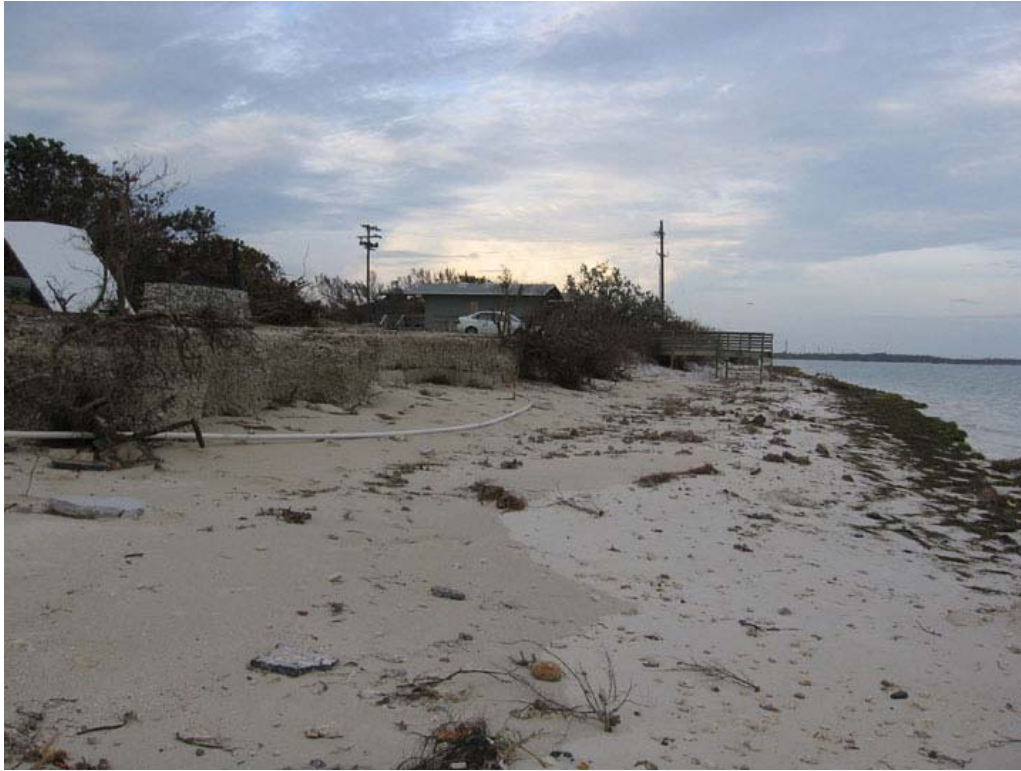
Loggerhead Beach – Exposed to the south waves of Wilma, Loggerhead Beach sustained moderate to major beach and dune erosion (condition III-IV). The erosion conditions were the greatest to the west of the bathhouse, where 300 feet of service road was lost to the erosion (Photos 30 & 31).

Photo 30. Severe erosion at Loggerhead Beach, Bahia Honda State Park.

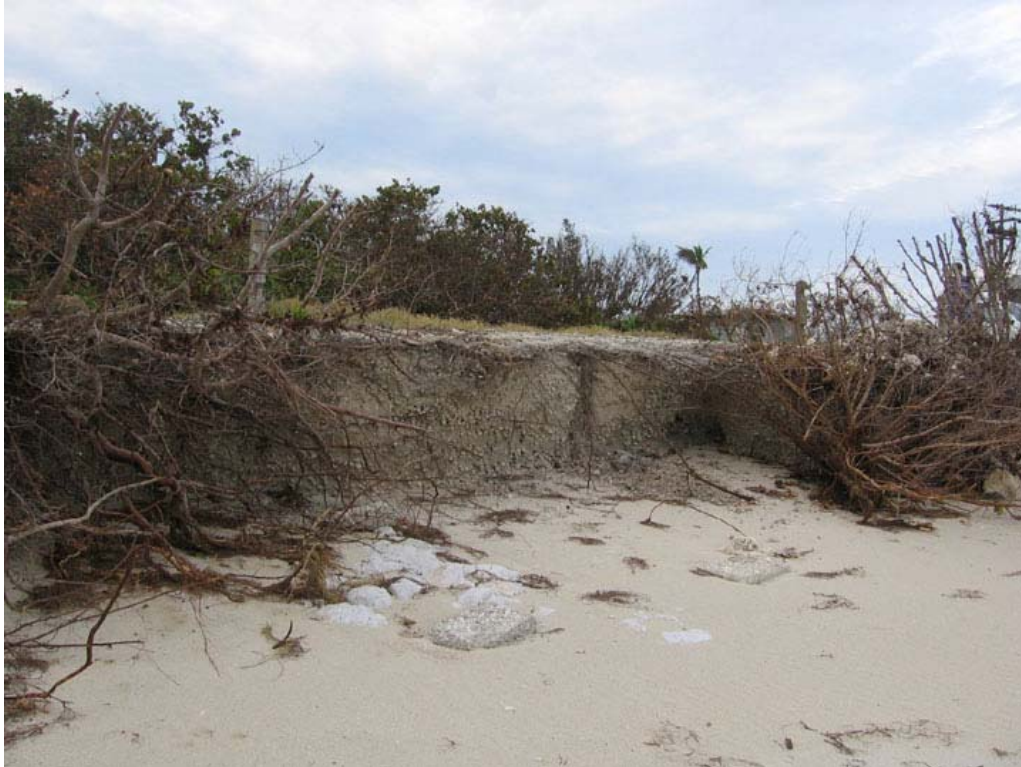
Photo 31. Eroded bluff at Loggerhead Beach, Bahia Honda State Park.

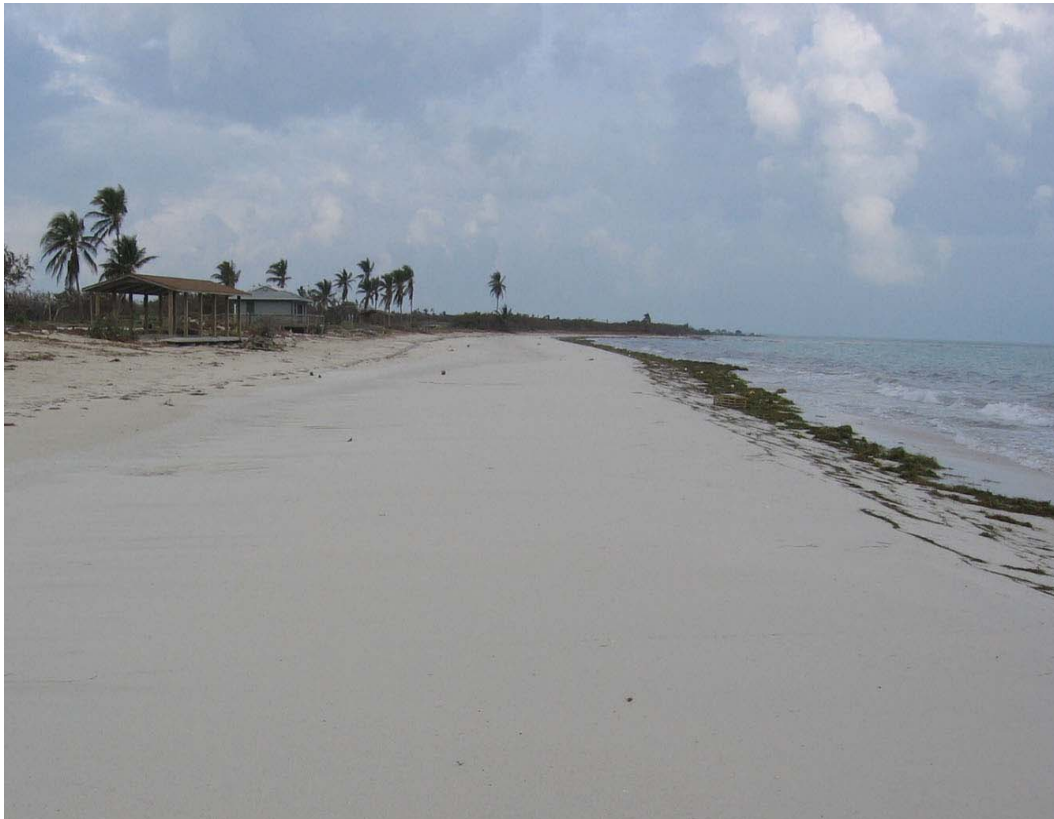
Sandspur Beach – As occurred during Hurricane Rita in September 2005, minor dune erosion (condition II) was sustained along Sandspur Beach; however, there was substantial accretion of the beach during the passage of Hurricane Wilma. Historically and prior to the 2005 hurricane season, the beach width at Sandspur Beach was roughly 50 feet (Clark, 1990). After Wilma, the beach width exceeds 100 feet (Photo 32). In contrast, on the east end of the island, condition IV erosion was sustained due to scour by the storm surge being conveyed through the Ohio Bahia Honda Channel.

Photo 32. Substantial beach accretion at Sandspur Beach, Bahia Honda State Park.

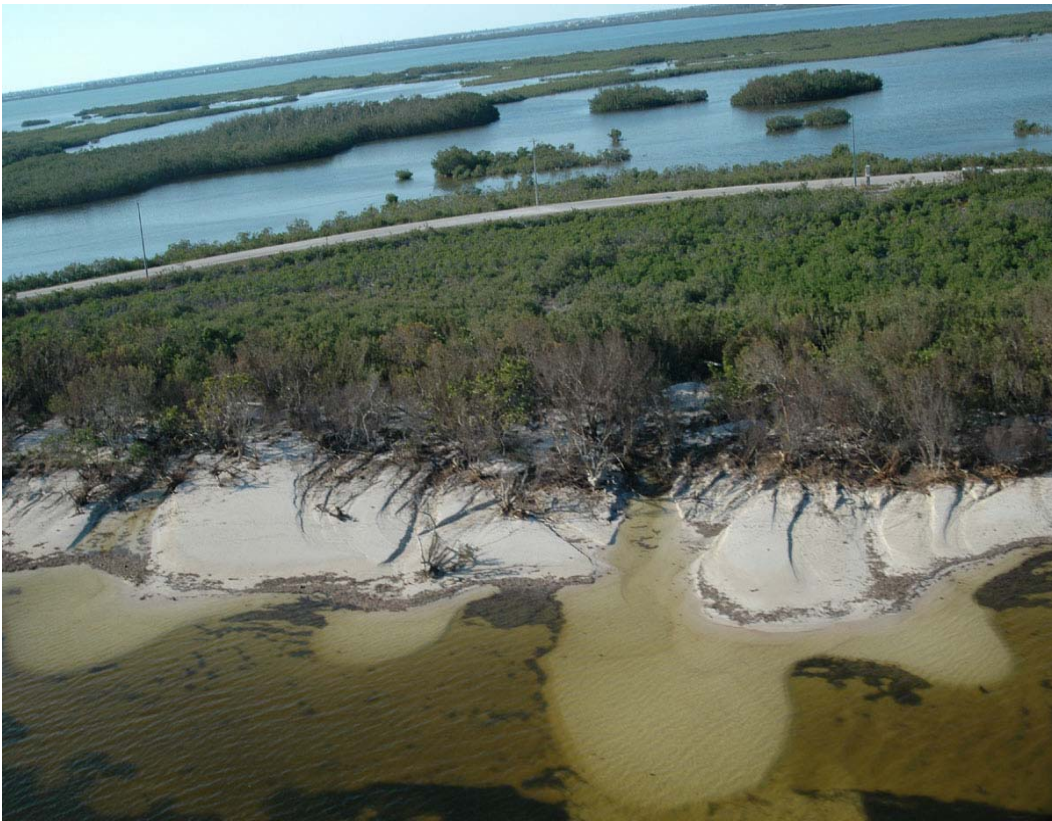
Key (Photo 33). Moderate to major beach and dune erosion (condition III-IV) was also sustained along the Newfound Harbor Keys.

Photo 33. Storm surge discharge channels, Long Beach, Big Pine Key.

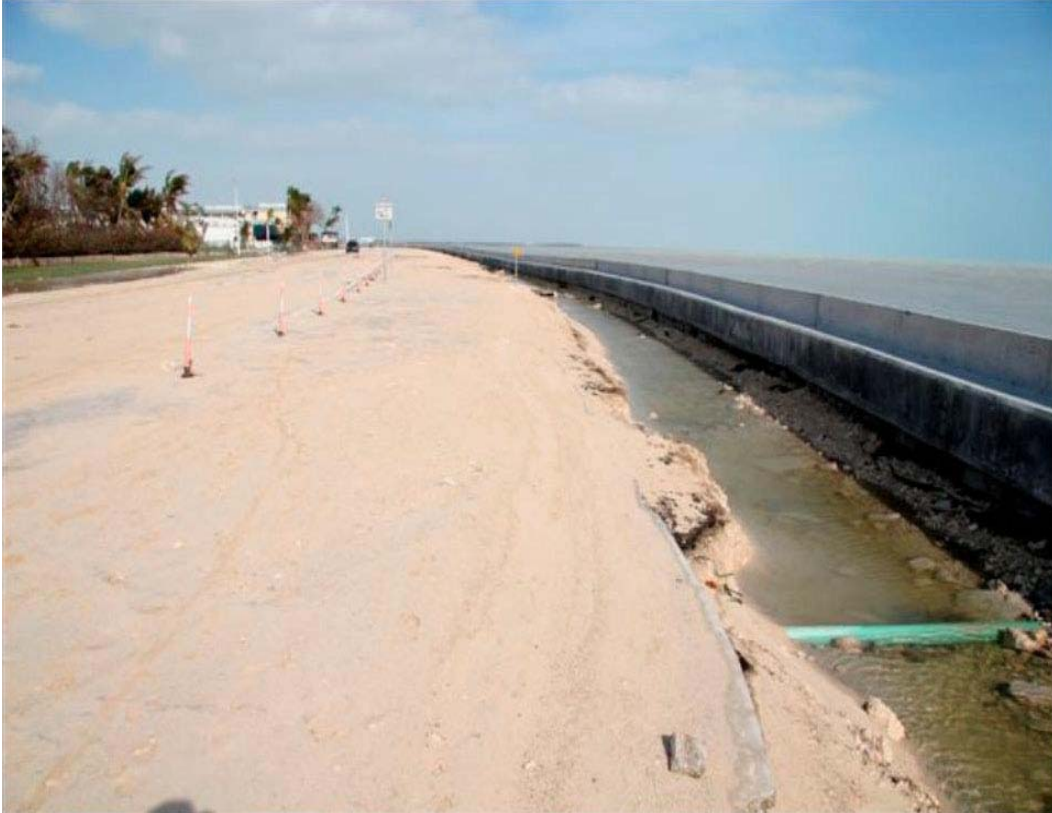
South Roosevelt Boulevard – The eastern three-quarters of a mile of seawalled shoreline fronting U.S. Highway A1A was overtopped by the storm tide and waves of Wilma. Significant scour was sustained landward of the seawall (Photo 34).

Photo 34. Scour behind seawall along South Roosevelt Boulevard  
(Credit: City of Key West).

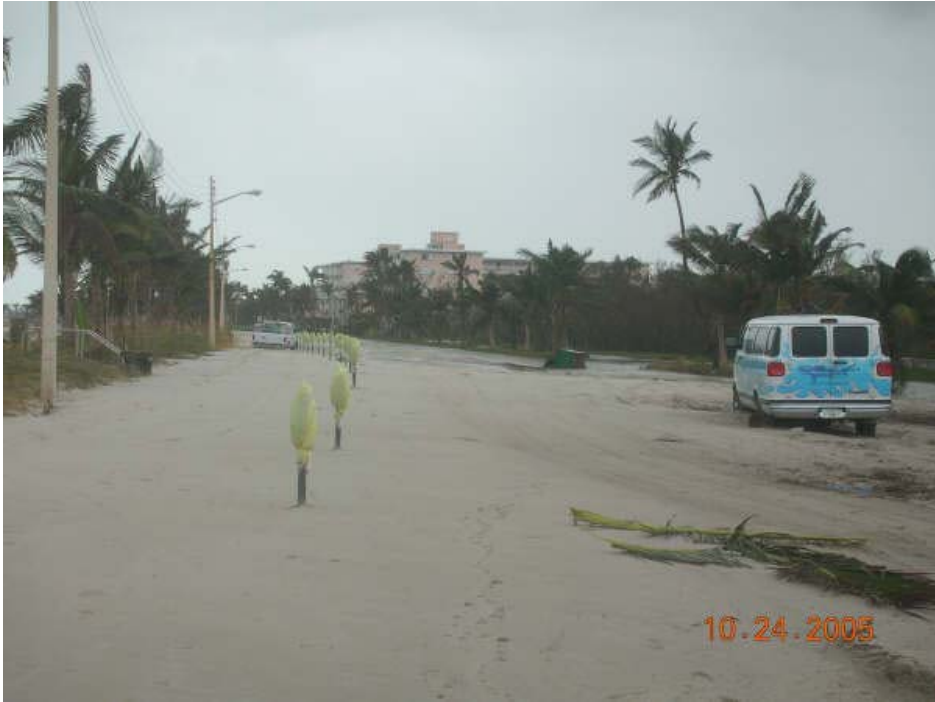
George Smathers Beach – The city’s 3,000-foot man-made public beach fronting the Straits of Florida sustained minor beach and dune erosion (condition II). Major overwash deposits of sand were carried across South Roosevelt Boulevard (Photos 35 and 36). The erosion was additive to the losses sustained during Hurricanes Dennis, Katrina, and Rita. No storm effects performance data will be available for the project; however, following recovery of all overwash sediments back to the beach system, surveys will be obtained to determine the net deficit of beach sand needed for future maintenance.

Photo 35. Overwash from Smathers Beach onto South Roosevelt Boulevard  
(Credit: City of Key West)

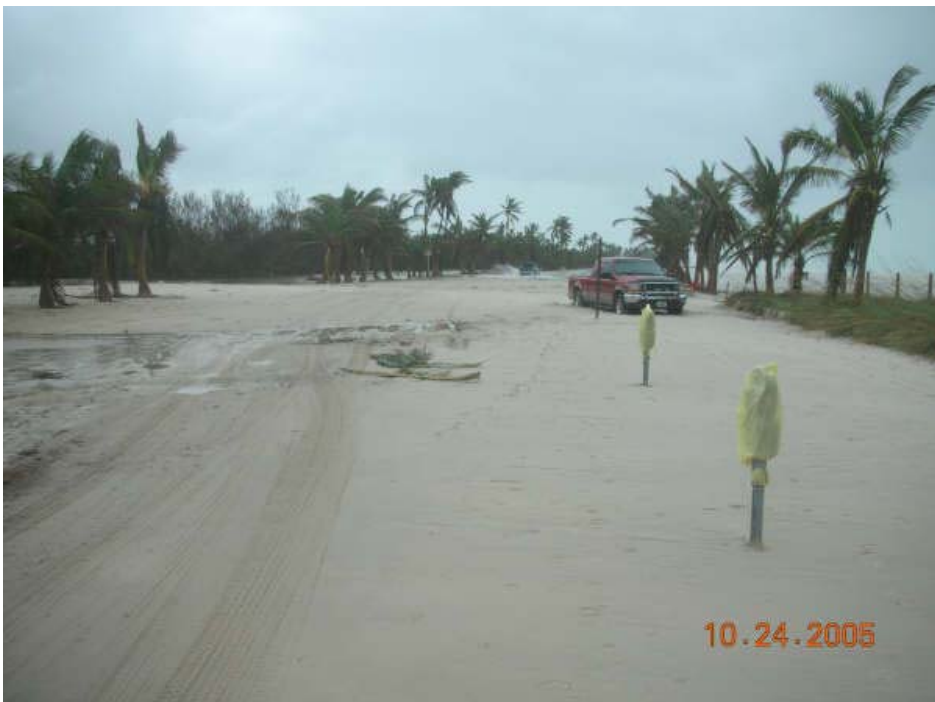
Photo 36. Overwash from Smathers Beach onto South Roosevelt Boulevard  
(Credit: City of Key West)

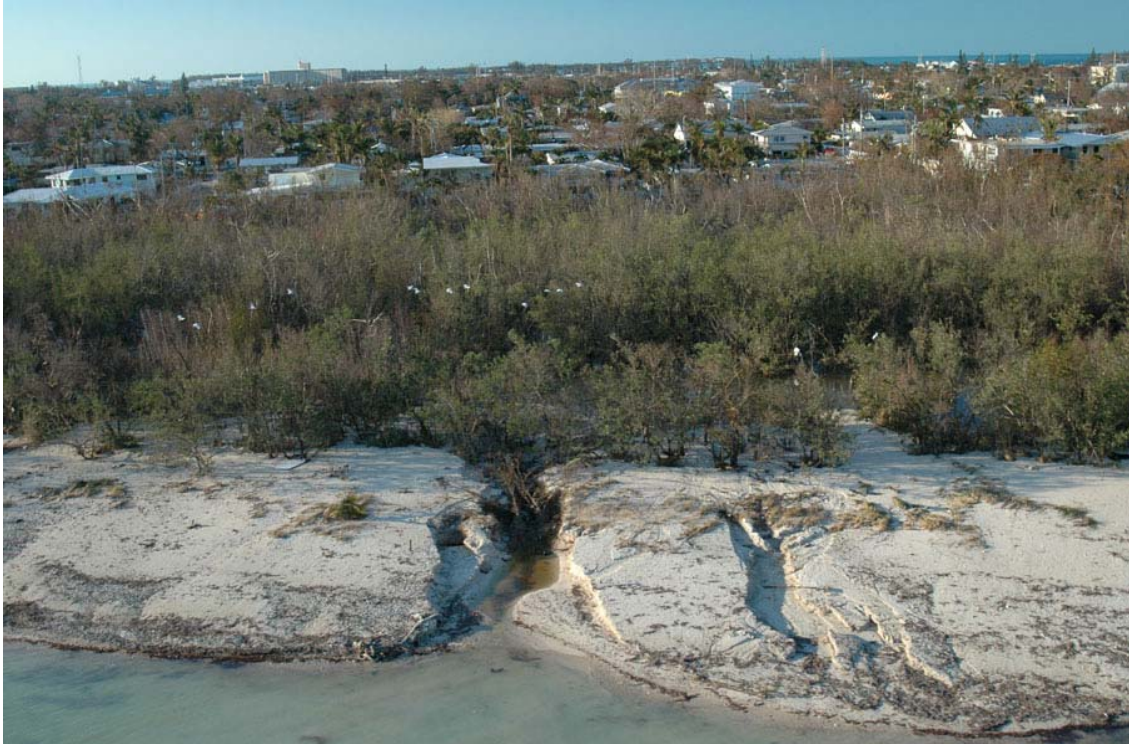
Berg and Kitsos Beach – To the west of Smathers Beach is a segment of straits fronting beach at the 1800 Atlantic Condominium and the City of Key West public beach known as Berg and Kitsos Beach. Moderate to major beach and dune erosion (condition III-IV) was sustained along this segment of shoreline. When the storm surge that inundated Key West withdrew, scour channels were carved across Berg and Kitsos Beach (Photo 37). The city will have to fill these storm surge discharge scour holes and channels. Additional beach sediments have been lost through overwash into the mangrove wetlands landward of the beach.

Photo 37. Scour channel, Berg and Kitsos Beach.

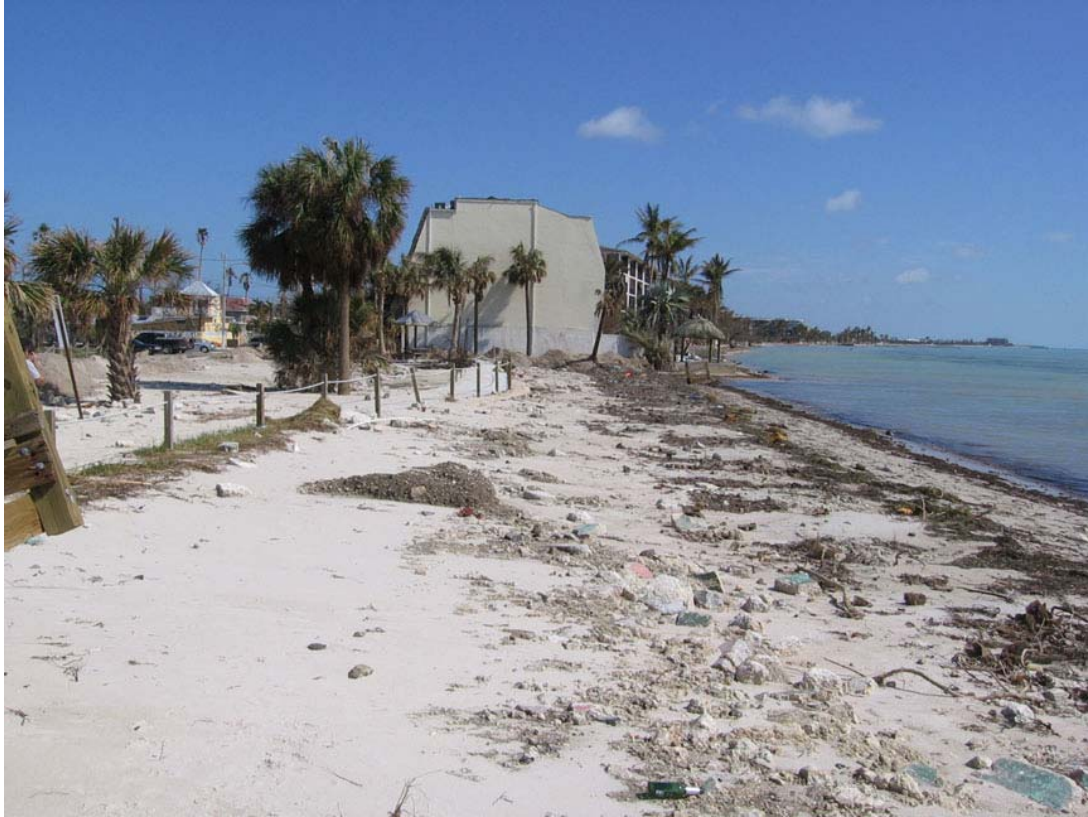
Rest Beach - The beach conditions at the City of Key West park known as Rest Beach substantially worsened. After Hurricane Rita, there was generally condition II erosion; however, after Wilma most of the park's shoreline had sustained major beach and dune erosion (condition IV) (Photo 38). Rita caused flooding and some overwash deposits onto Atlantic Boulevard, but Wilma inflicted severe erosion, flooding, and overwash, and substantially destroyed the entire park's recreational infrastructure (see Wilma damage discussion). This critically eroded beach is not expected to naturally recover to its pre-2005 beach condition, as most of its sand loss has been due to overwash deposits.

Photo 38. Major beach and dune erosion at Rest Beach, Key West.

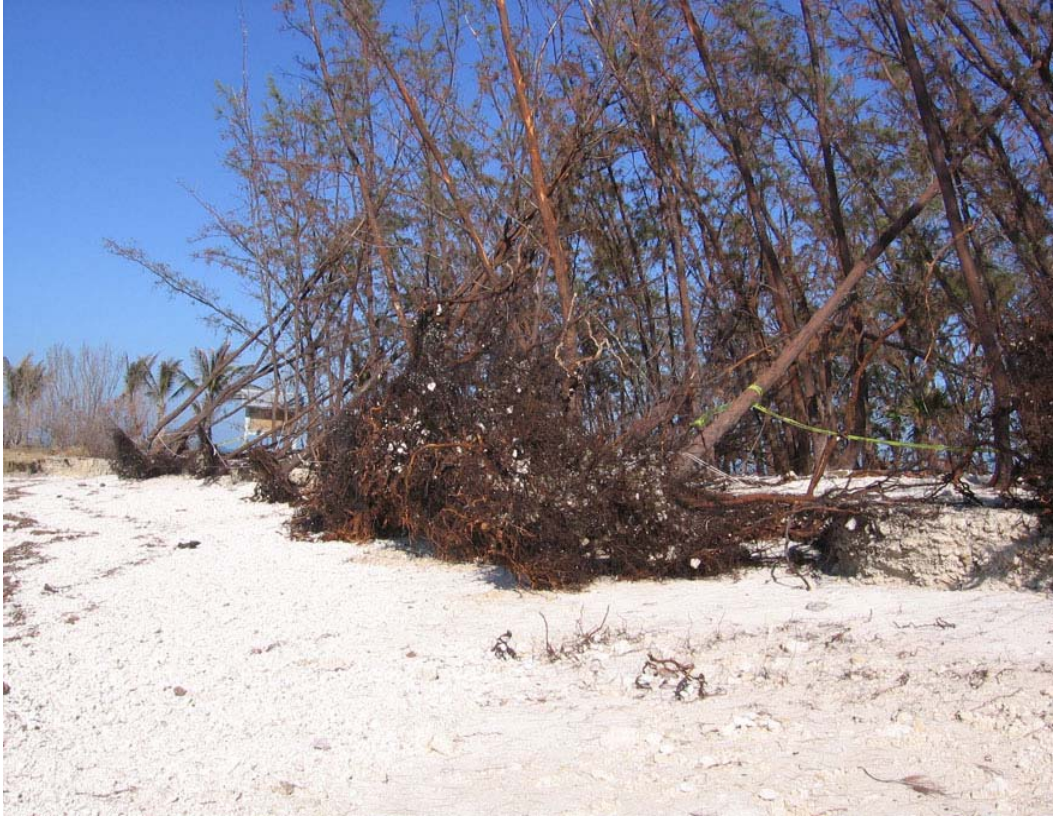
Fort Zachary Taylor Historic State Park – As occurred during Hurricane Rita, continued minor beach and dune erosion (condition II) was sustained along the eastern half of the park's shoreline during Wilma. From the middle of the park's shoreline to the west end at the terminal groin, erosion conditions worsened from moderate to major beach and dune erosion (condition III to IV). Wilma's southwest storm waves propagating on the storm surge across the Key West Ship Channel inflicted substantial dune recession near the terminal groin (Photo 39). In addition, the west shoreline of the park, exposed to waves from both the straits and the gulf, sustained moderate upland bank erosion (condition III) behind the rock revetment.

Photo 39. Severe dune erosion, Fort Zachary Taylor Historic State Park.

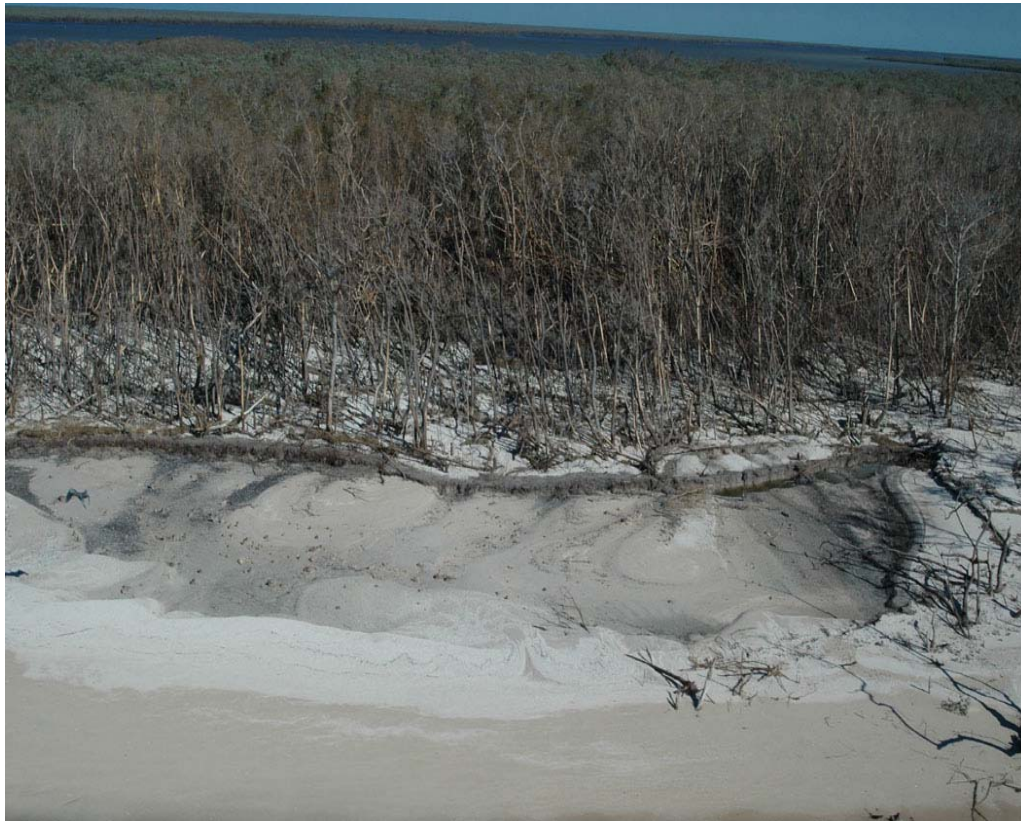
The maximum wind field and highest storm surge of Hurricane Wilma devastated the 12.2 miles of carbonate sand and shell beaches of Cape Sable. Severe beach and dune erosion (condition IV) was sustained throughout this undeveloped region on the mainland gulf coast of Monroe County (Photo 40). Along segments where important sea turtle nesting habitat has been lost, the beaches have become critically eroded.

Photo 40. Severe beach erosion north of the Northwest Cape (Cape Sable).
