## Monroe County

### **Storm Effects and Erosion Conditions**

### **Storm Damage**

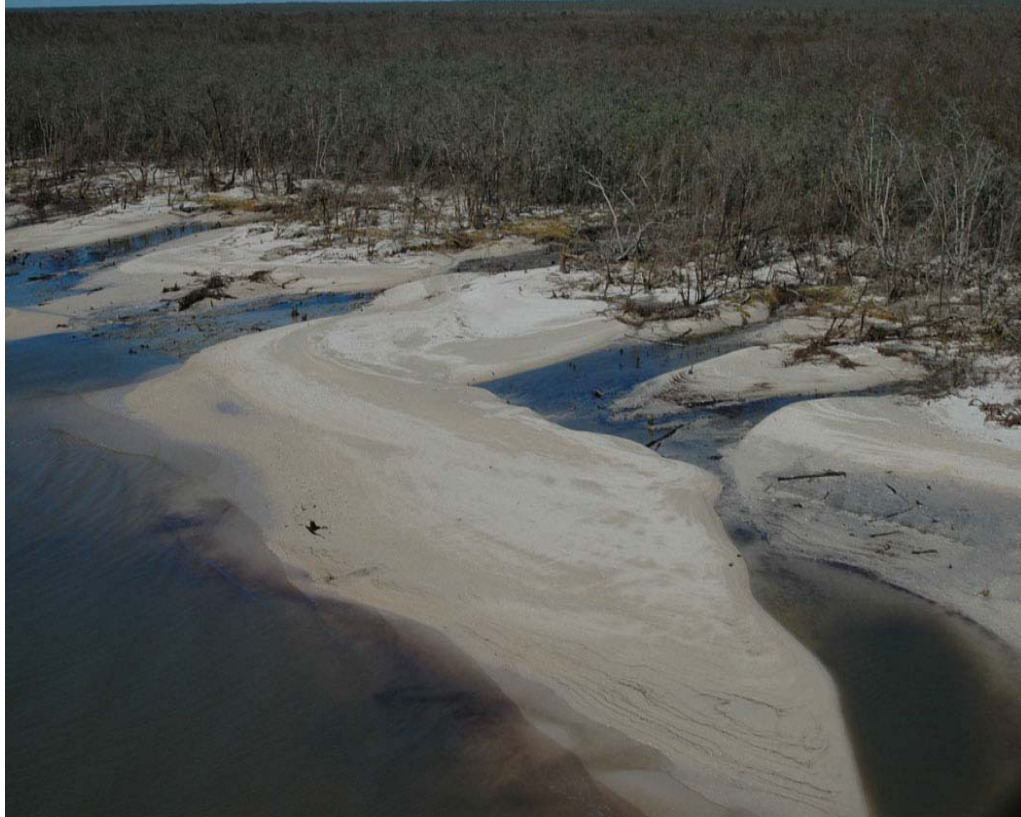
The maximum wind field and highest storm surge of Hurricane Wilma devastated the discontinuous carbonate sand and shell beaches of this region. Severe beach and dune erosion (condition IV) was sustained throughout this undeveloped region on the mainland gulf coast of Monroe County (Photo 41). Along segments where important sea turtle nesting habitat has been lost, the beaches have become critically eroded.

Photo 41. Storm surge scour channels between Shark River and Pavilion Key.

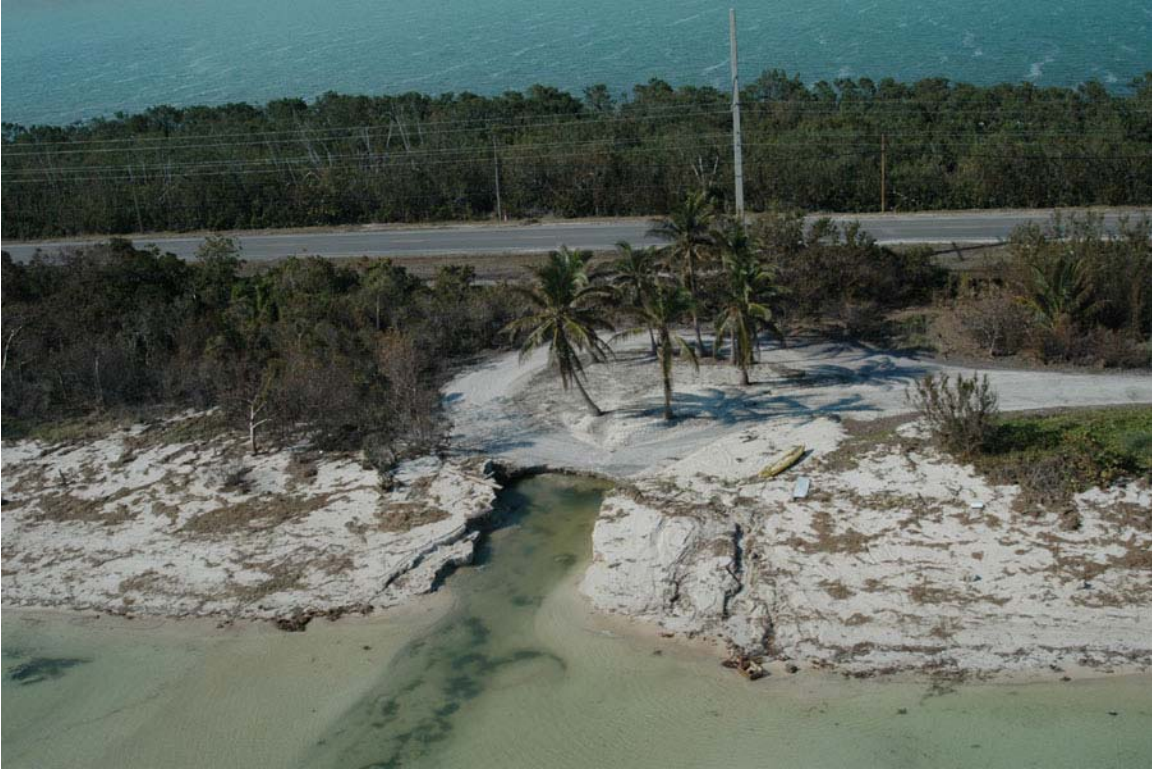
As previously discussed, Wilma significantly worsened the beach conditions and the 60 camp sites that were destroyed. West of the campgrounds, 50 feet of the end of the park road was destroyed by a storm surge discharge channel that has created a deep gully across the dune and beach (Photos 42 and 43). In addition, the 650-foot rock revetment east of the campsites that was both damaged and overtopped during Rita, sustained additional level three damage.

Photo 42. Storm surge discharge gully, Long Key State Park.

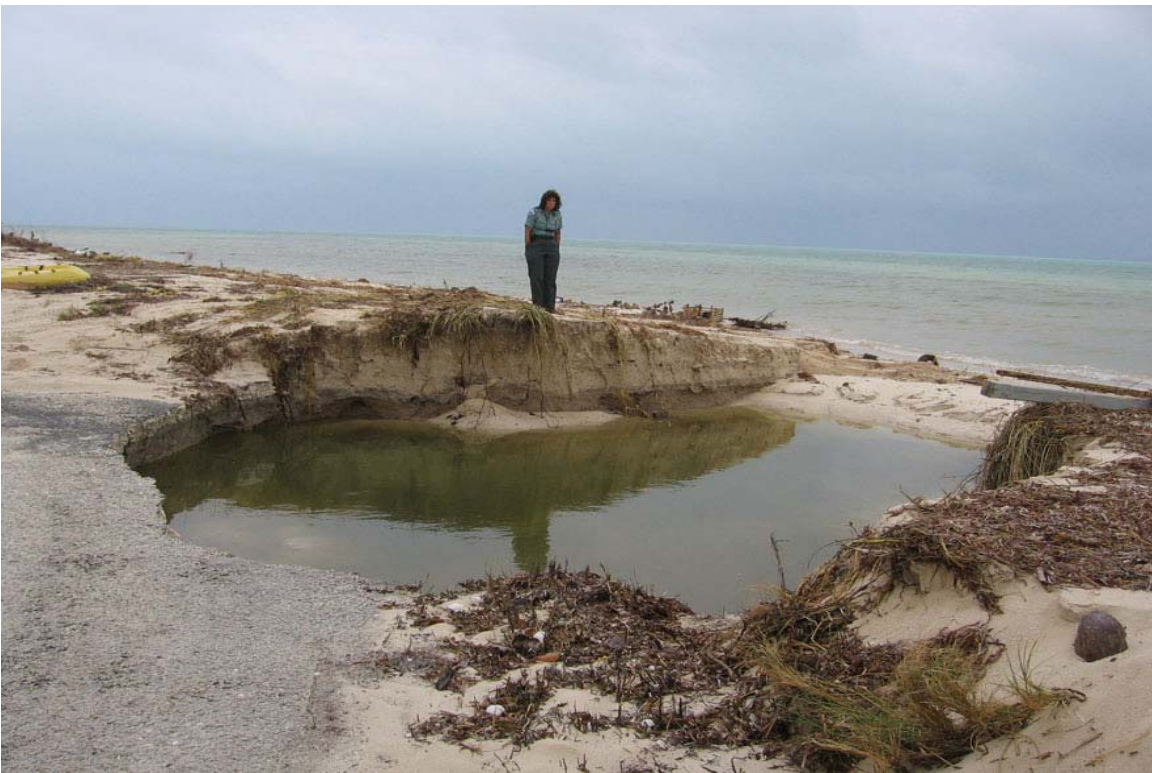
Photo 43. Storm surge discharge gully, Long Key State Park.

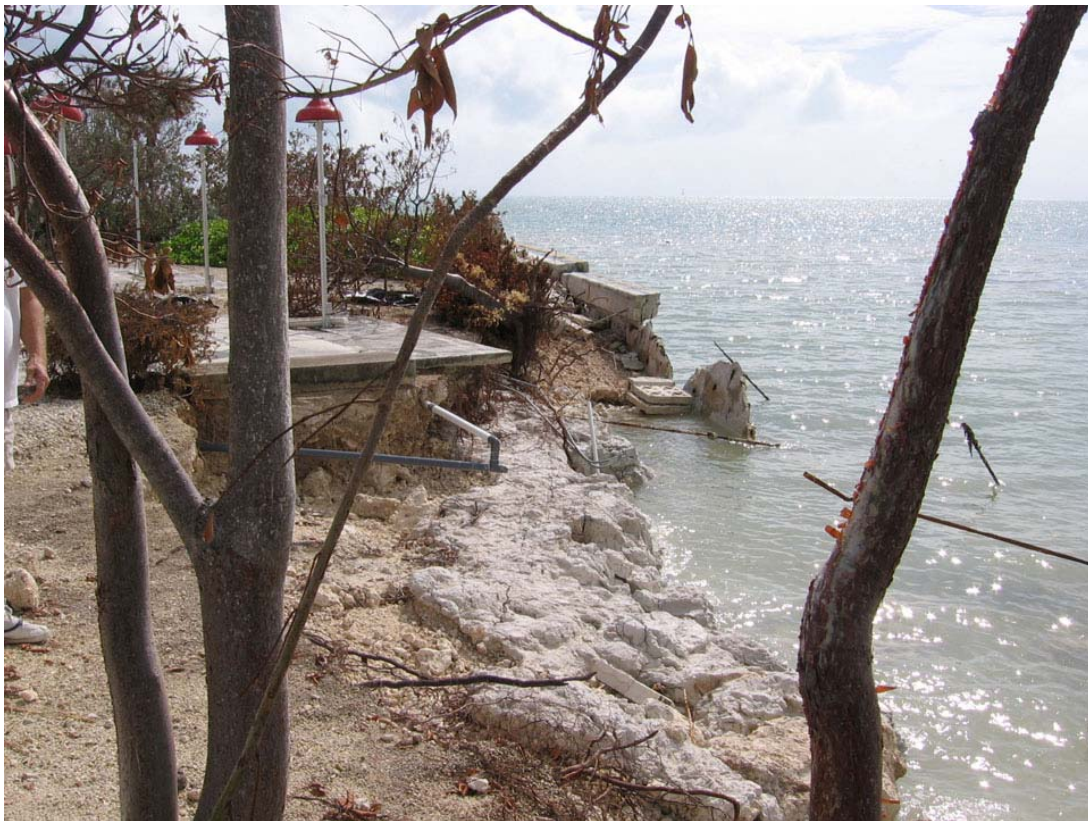
On Vaca Key, two seawalls (totaling 125 feet) and four rock revetments (totaling 150 feet) were destroyed or substantially damaged. In addition, six piers fronting the Straits of Florida were destroyed. On Tingler Island, two seawalls were damaged. One 90-foot concrete seawall on the exposed west shoreline was totally destroyed (level four damage) (Photo 44) and another 100-foot concrete seawall was damaged (level two damage). At the city's public beach, Sombrero Beach, much of the park's infrastructure was damaged, including beach access walkways, picnic shelters, fences, trees and shrubs. In addition, 35 feet of the end of the asphalt paved road at Sombrero Beach was destroyed. Offshore, all the trees on the small island of West Sister Rock were completely removed by the storm surge, wind and waves.

Photo 44. Seawall destroyed by Wilma, Tingler Island.

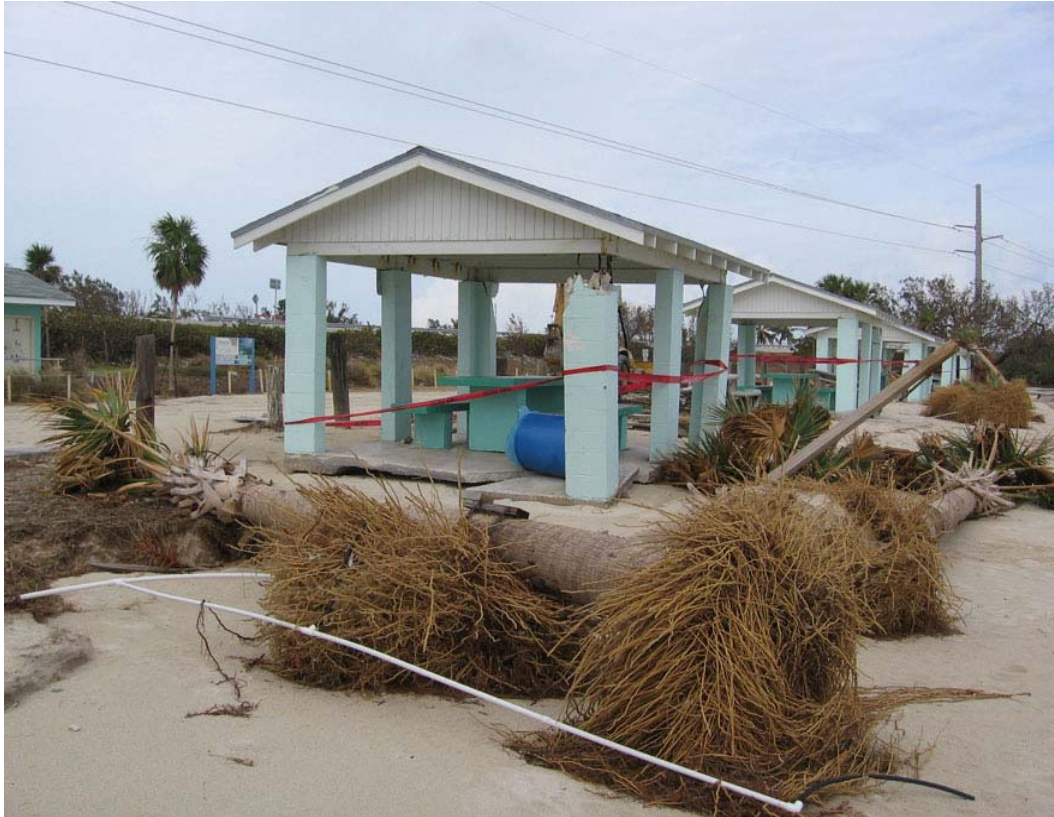
Veteran’s Memorial Park, a Monroe County beach, was severely impacted by the storm surge and waves of Wilma. Five concrete picnic shelters were substantially damaged and rendered irreparable (Photo 45).

Photo 45. Damaged picnic shelter, Little Duck Key.

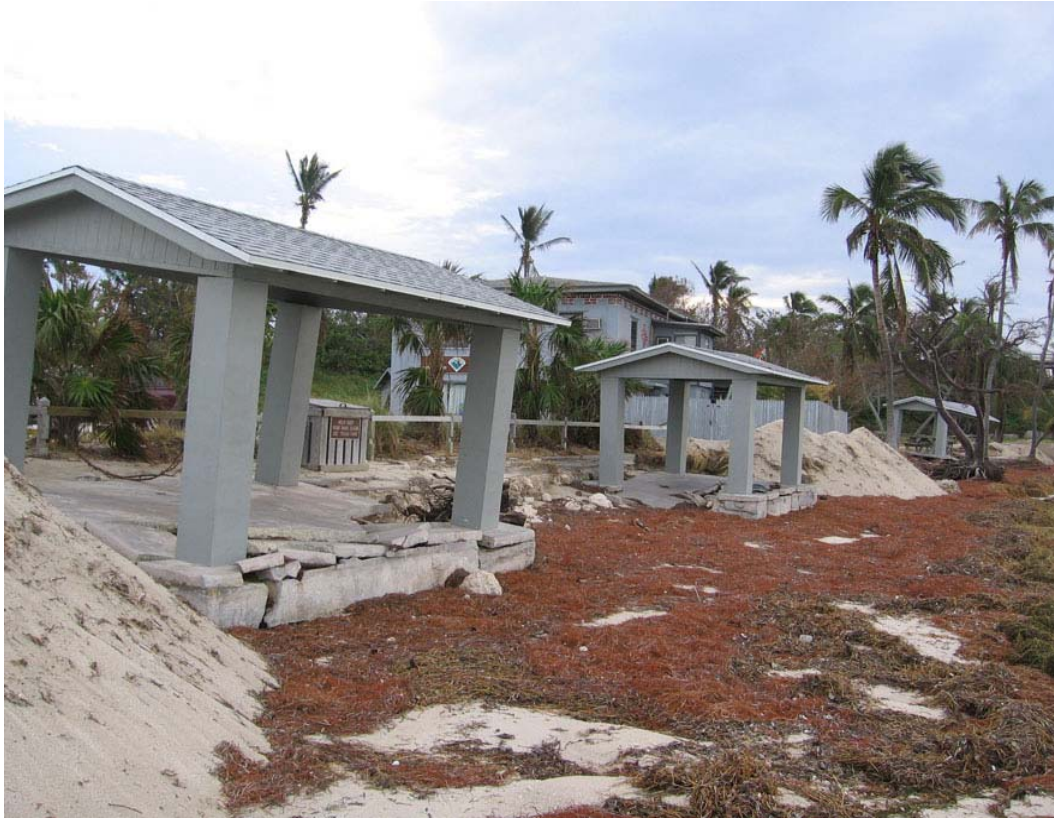
Calusa Beach – The park’s public beach facilities on Calusa Beach were substantially damaged by the storm surge and waves of Wilma from the Gulf of Mexico that propagated across the bay of Bahia Honda. The north half of the beach sustained significant overwash, which transported sand into the public parking area and the northern four picnic shelters. The middle two concrete picnic shelters were undermined, but are being salvaged by the emergency placement of sand obtained from overwash deposits. The southern three concrete picnic shelters were destroyed by the storm surge and waves (Photo 46). In addition, the park’s interpretive center building is presently threatened by the condition IV erosion.

Photo 46. Destroyed picnic shelters, Calusa Beach, Bahia Honda State Park.

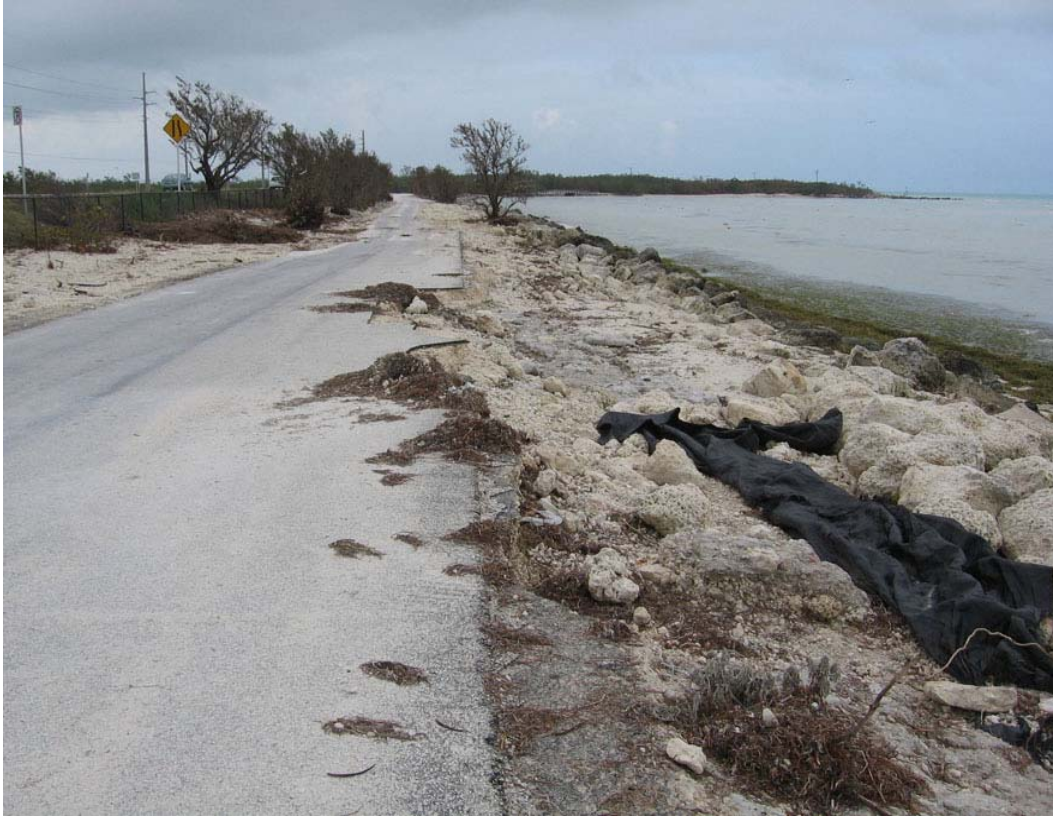
Road to Sandspur Beach – Along the road east of the park entrance, about 600 feet of rock revetment was substantially damaged (level four damage) and 75 feet of road had pavement damage (Photo 47).

Photo 47. Road and revetment damage, Bahia Honda State Park.

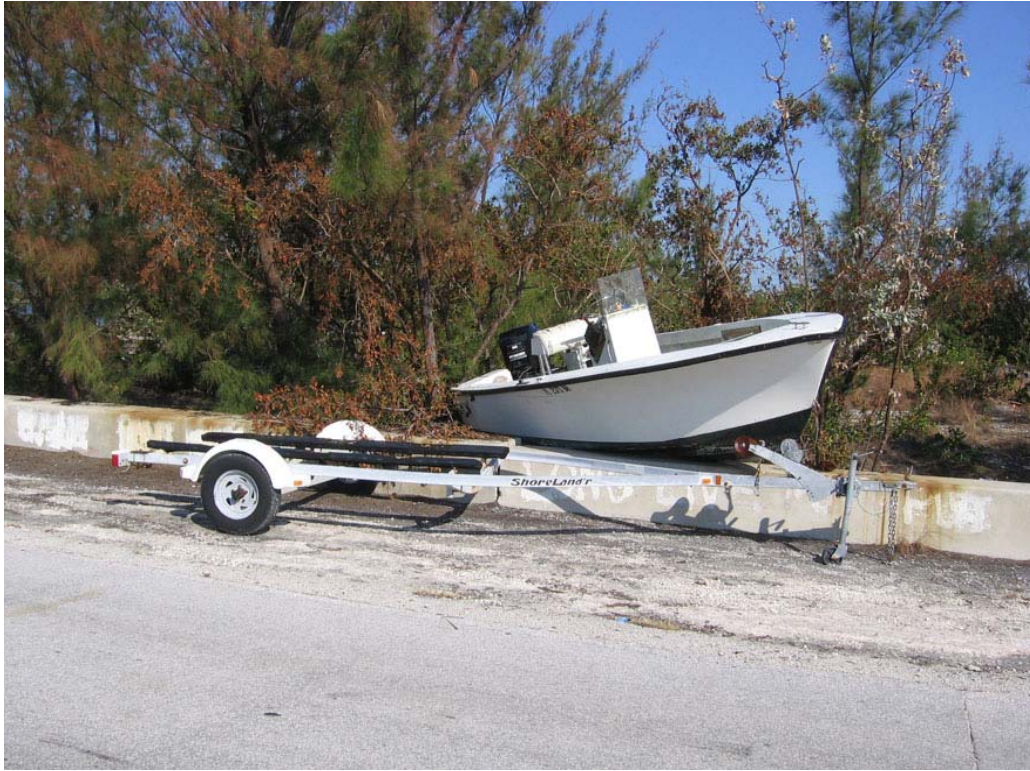
Moderate to major flooding damages were sustained to residential and commercial development throughout the lower keys. Flood damage figures are currently being developed by Monroe County, and will be included in any future update to this report. Light to moderate wind damage was also sustained throughout the lower keys, including damages to roofing, siding, signs, fences, trees and shrubs. Docks, bulkheads, and other marina facilities, as well as small craft (recreational and commercial vessels) were particularly hard hit by the storm surge (Photos 48 and 49).

Photo 48. Trailered boat damaged by Wilma's storm surge on Stock Island.

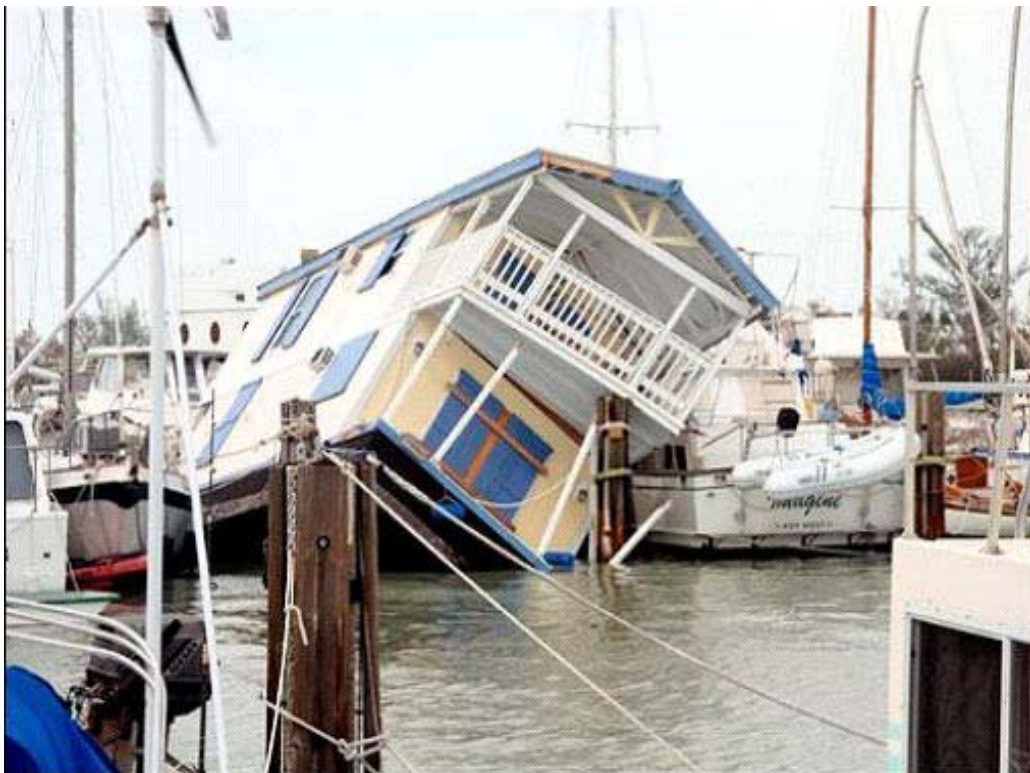
Photo 49. Damaged house boat, Garrison Bight.

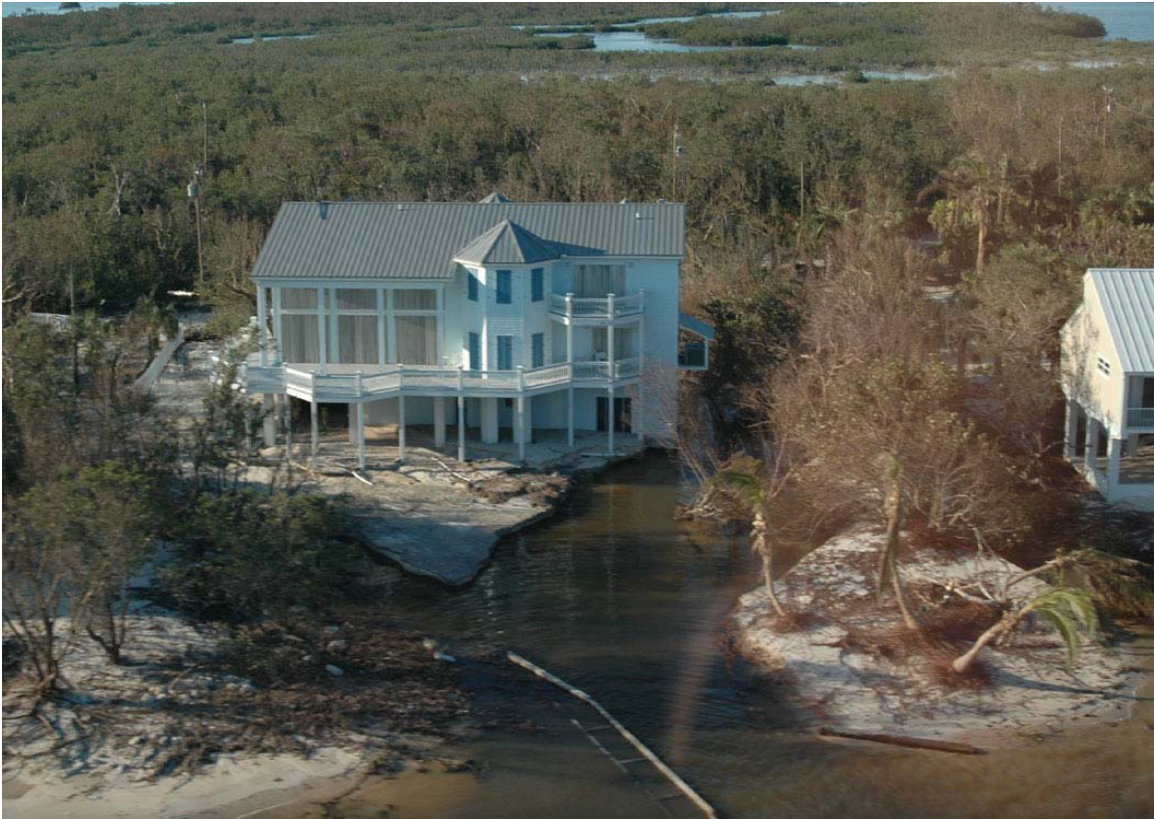
Additional damages were realized along the Straits of Florida shoreline. On Big Pine Key, a 100-foot rock revetment was destroyed. On the Newfound Harbor Keys, a single-family dwelling was destroyed and others sustained major flood damage. On Munson Key, a pier was substantially damaged, and on Cudjoe Key nine piers were destroyed or substantially damaged. Along the Cudjoe Bay shoreline, numerous docks, boats, and gazebos were damaged, along with 150 feet of rock revetment and two concrete seawalls (200 feet). On Sugarloaf Key, three piers, 200 feet of concrete seawalls, and 100 feet of rock revetments were destroyed. One single-family dwelling was destroyed by the storm surge and two other dwellings are imminently threatened by the erosion conditions (Photo 50). On Geiger Key, another single-family dwelling was destroyed by the storm surge, and 50 feet of rock revetment was damaged.

Photo 50. Imminently threatened dwelling, Sugarloaf Key.

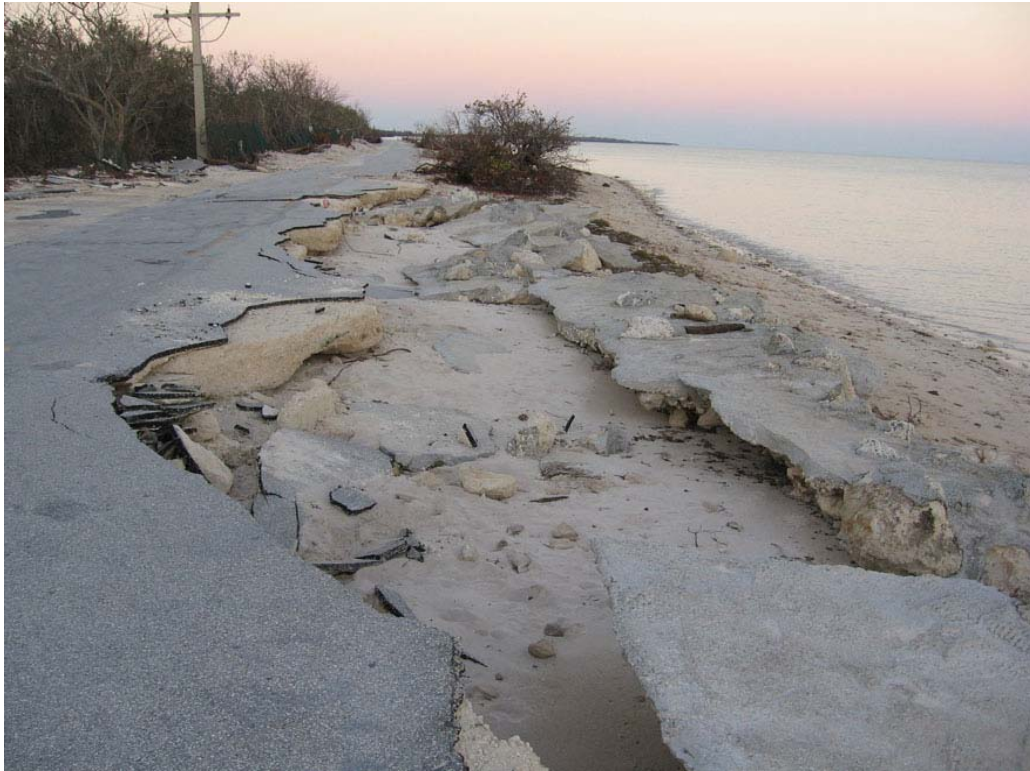
Along with the erosion and overwash of 1480 feet of Boca Chica Beach Road at the Monroe County park, 620 feet of the road was destroyed or substantially damaged (Photos 51 and 52). West of the county park, two additional 1000-foot segments of the paved road at the Naval Air Station were destroyed.

Photo 51. Boca Chica Beach Road damaged.

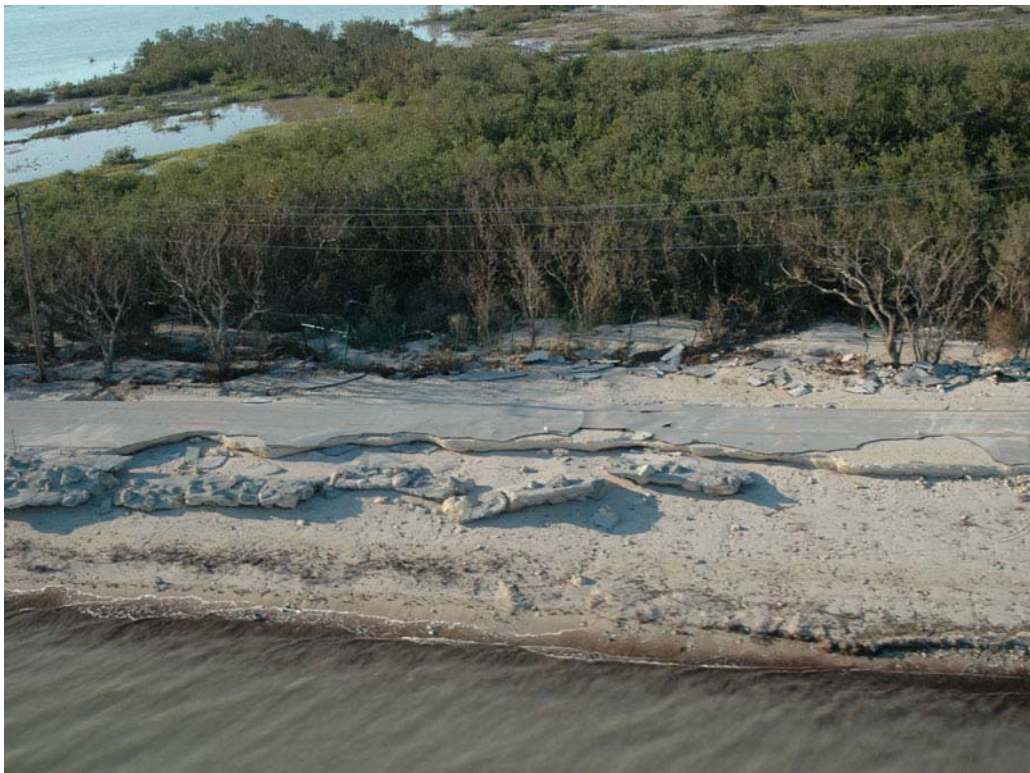
Photo 52. Boca Chica Beach Road damaged.

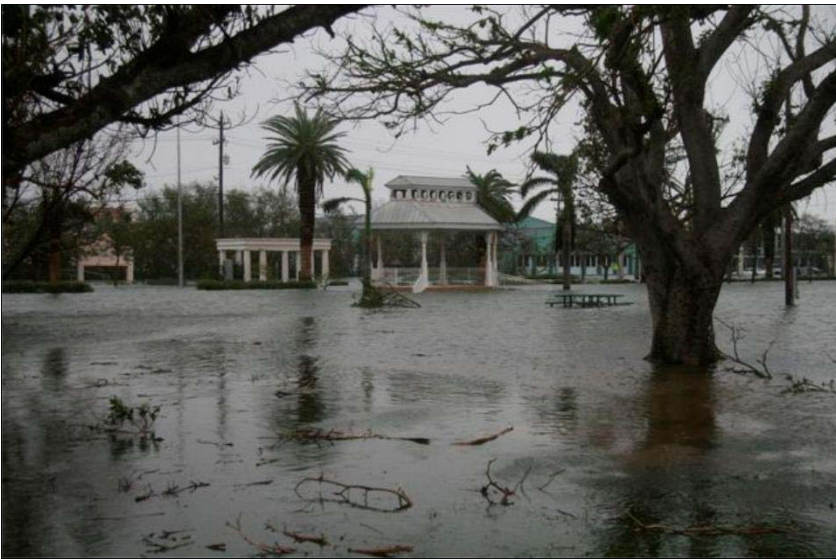
Throughout the City of Key West, moderate to major flooding damages were sustained to residential and commercial development. An estimated 35 percent of the city was flooded impacting infrastructure and utilities as well as city parks (Photo 53). A large number of vehicles were also destroyed by the flood waters. Widespread light to moderate wind damage was sustained throughout the city (Photo 54).

Photo 53. Key West interior city park flooding.

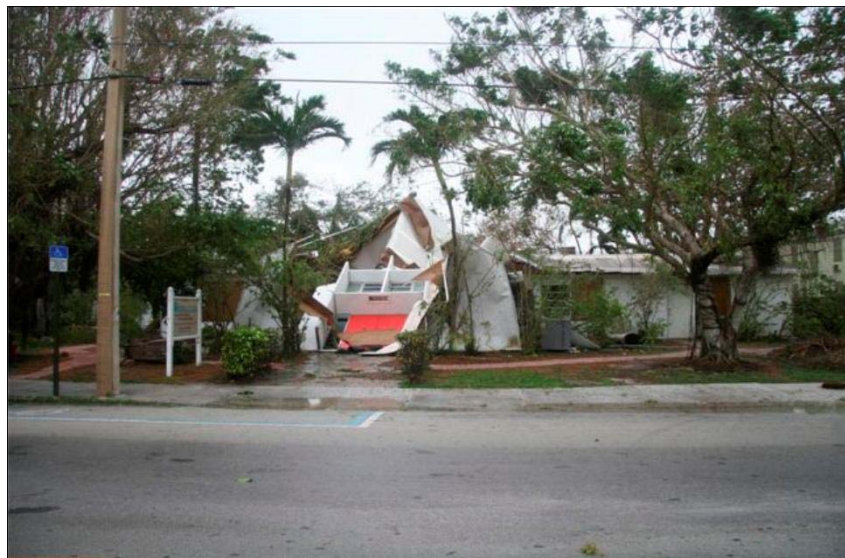
Photo 54. Key West wind damage.

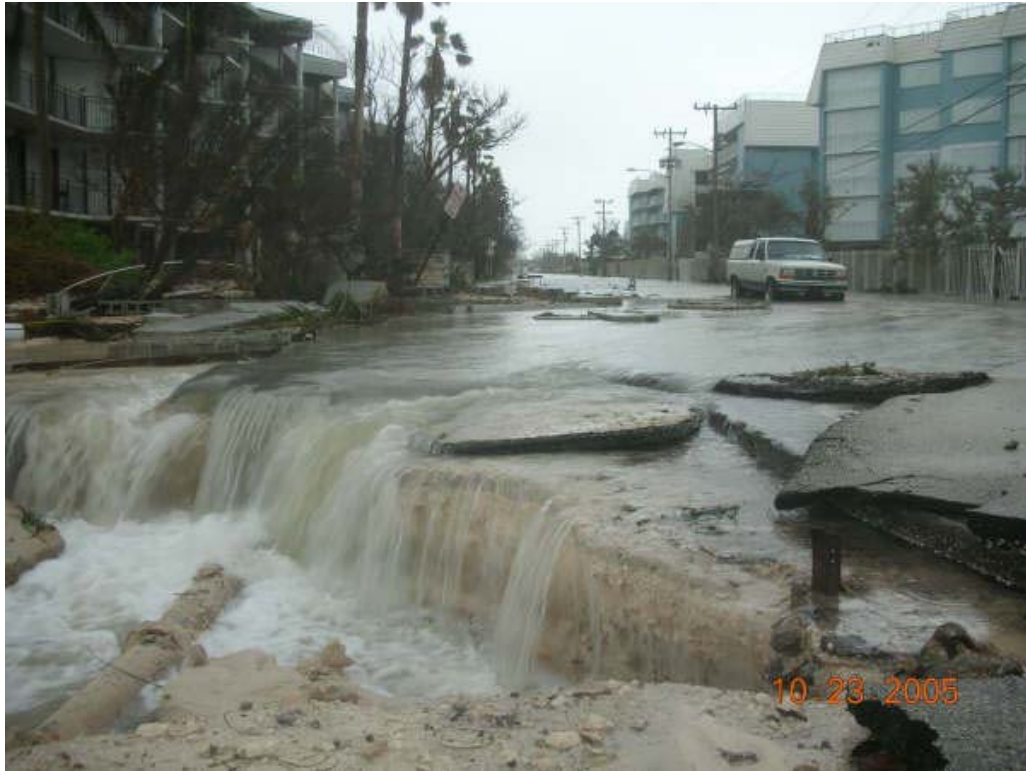
South Atlantic Boulevard and Bertha Street – Roughly 50 feet of the street end at Bertha Street and another 25 feet of South Atlantic Boulevard was damaged (Photos 55 and 56).

Photo 55. Bertha Street during Wilma's falling storm surge.  
(Credit: City of Key West)

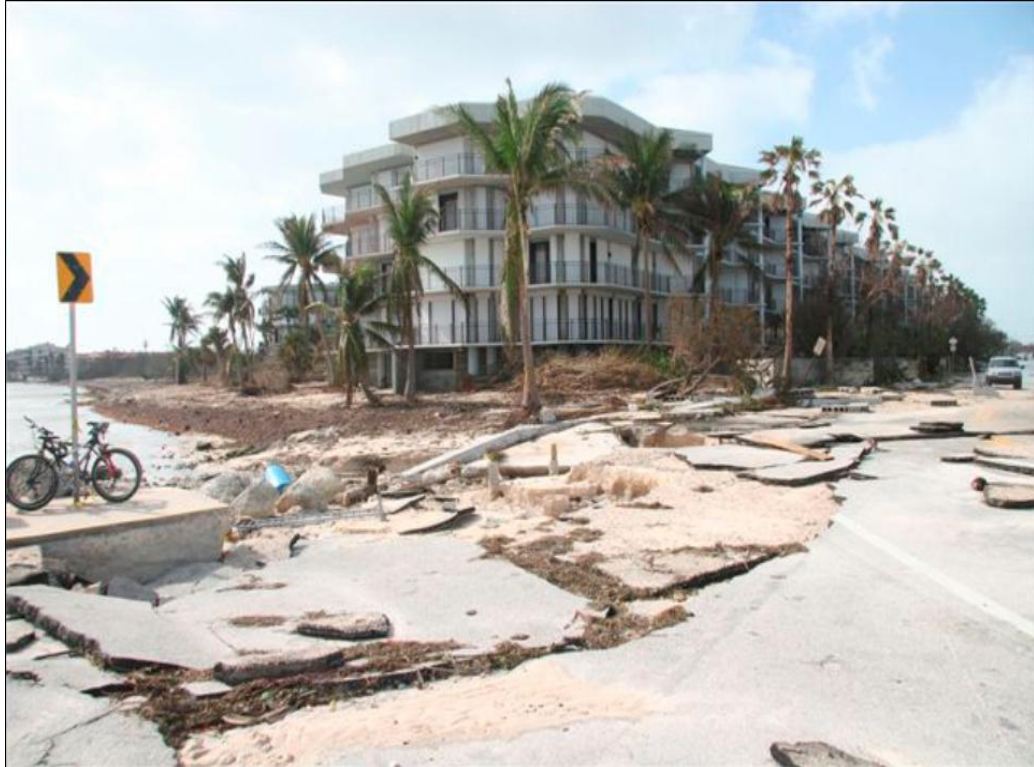
Photo 56. Bertha Street damaged. (Credit: City of Key West)
